SR 105 MP 20 Washaway Beach 2018 Dynamic Revetment Monitoring Report

**Rob Schanz PE, LG, Hydrologist
Garrett Jackson LG, Hydrology Program Manager
WSDOT Headquarters Hydraulics Office**

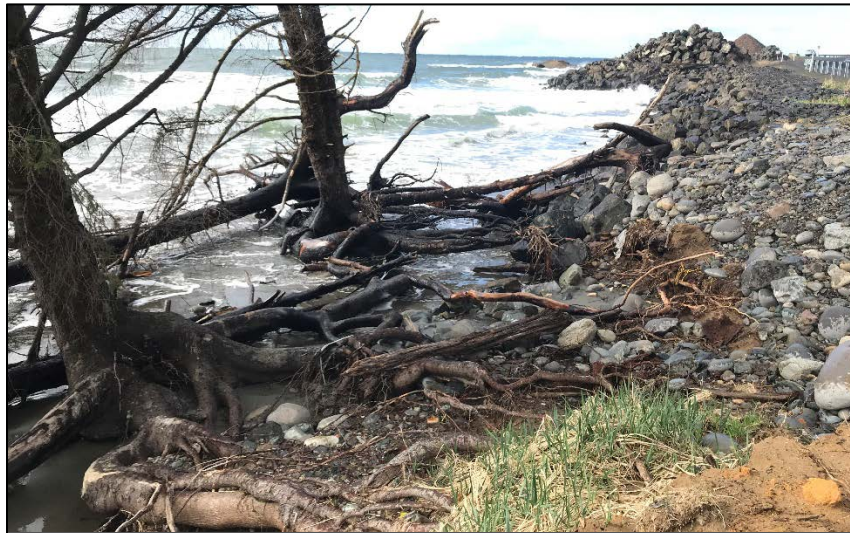
Figure 8 Loss of remnant terrace material at the west end of the project after the January storms

In late January WSDOT Maintenance observed erosion of the terrace that previously buffered the western end of the dynamic revetment from wave action. This exposed the roots of the remnant trees in this area and caused some displacement of cobbles on the seaward slope of the dynamic revetment (Figure 8). No significant changes were observed after January. No significant loss of berm width was observed at the transect stakes, and no emergency repairs were performed.

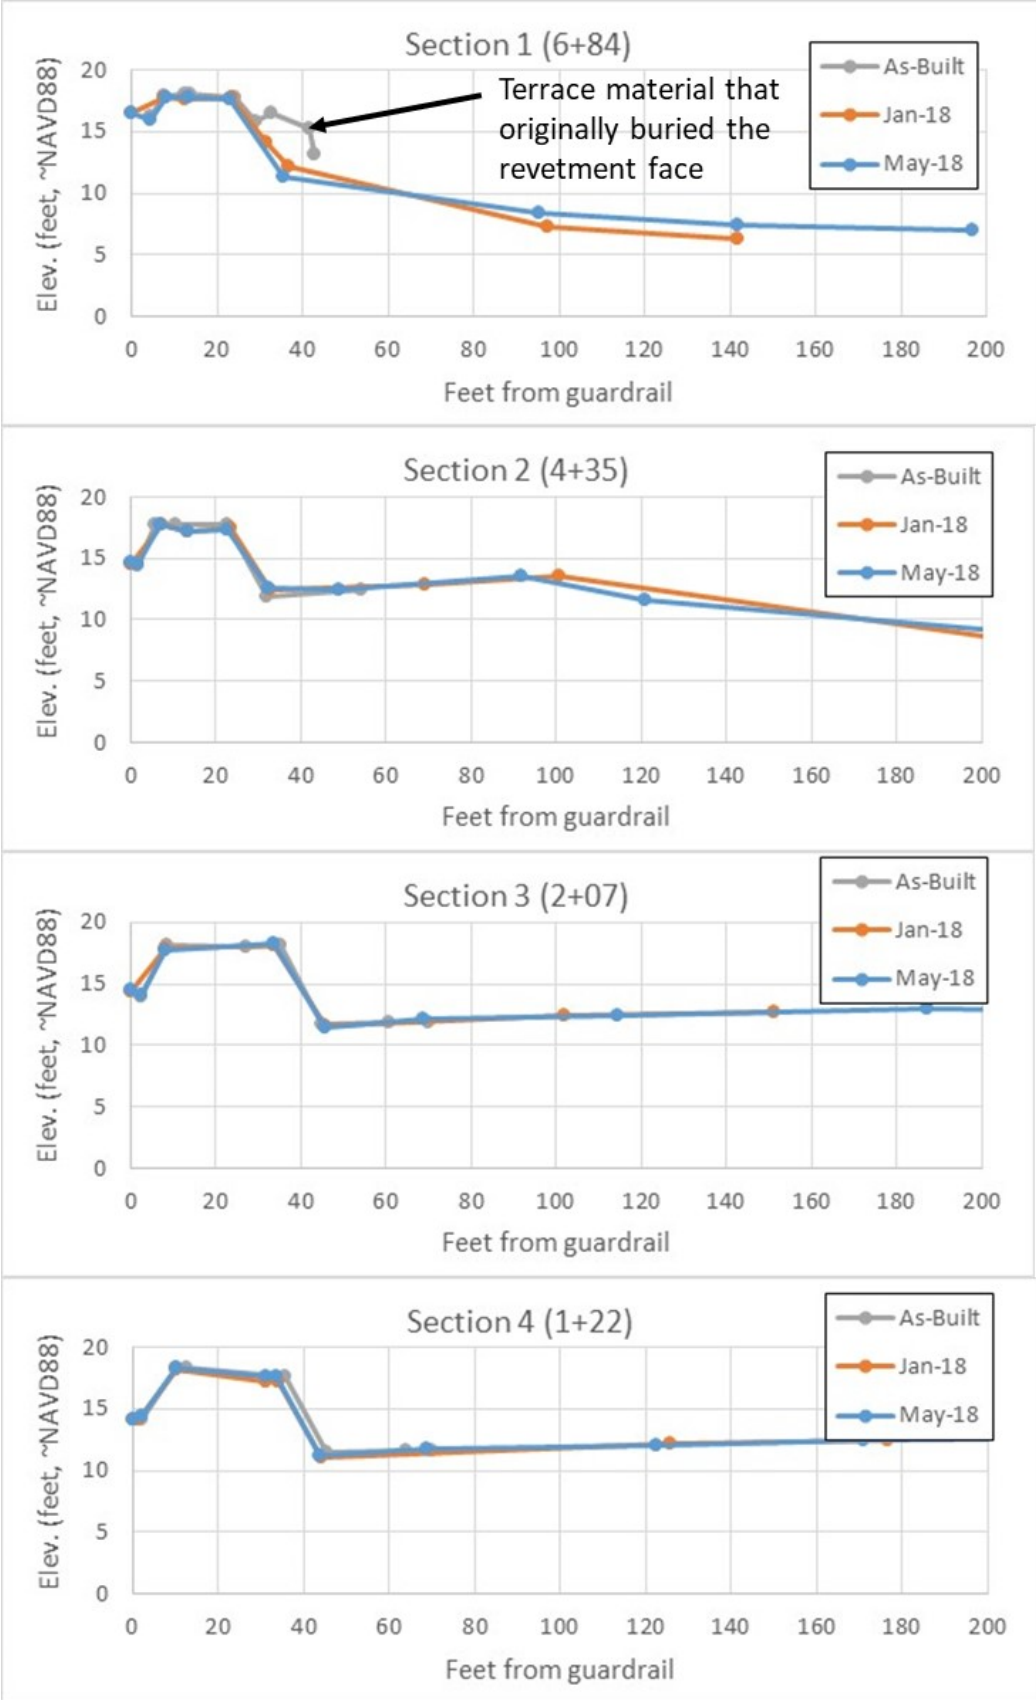
Figure 9 Comparison of As-Built, January, and May transect surveys

Detailed site surveys were performed on January 24 and May 18, 2018. Appendix B compares representative photos from each monitoring visit, and Figure 9 compares the transect survey data. Most of the dynamic revetment east of Section 1 saw little wave action and has not significantly deformed relative to the As-built condition. Changes in this area are subtle and are likely caused by settlement and shifting of the loose cobble material.

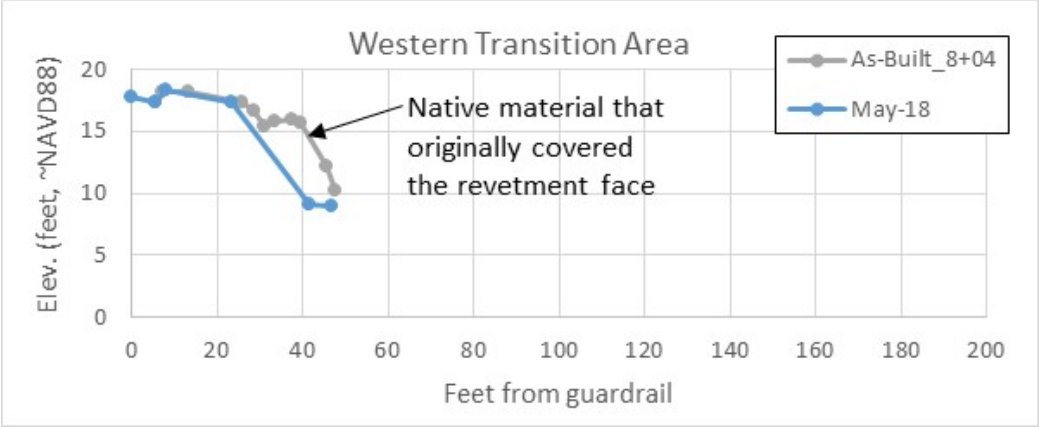
Figure 10 Transect in the center of the west transition area

The west transition from dynamic revetment to older maintenance repairs saw the most significant changes. Figure 10 shows a cross section in this area. This segment was constructed in a trench behind remnant upland terrace material. Most of this terrace material was removed during the January storms, exposing the face of the dynamic revetment to wave action between Section 1 and the west end. This reduced the revetment top width by about 2- to 3-feet in a 35-foot long segment as cobbles along the face slumped and rolled down to the beach (Figure 11). The face of the dynamic revetment here is now somewhat uneven due to pockets of remnant terrace material. Gravel and small cobbles were found scattered among driftwood on the beach east of this area, indicating downdrift transport of material eroded from the face of the revetment (Figure 12).

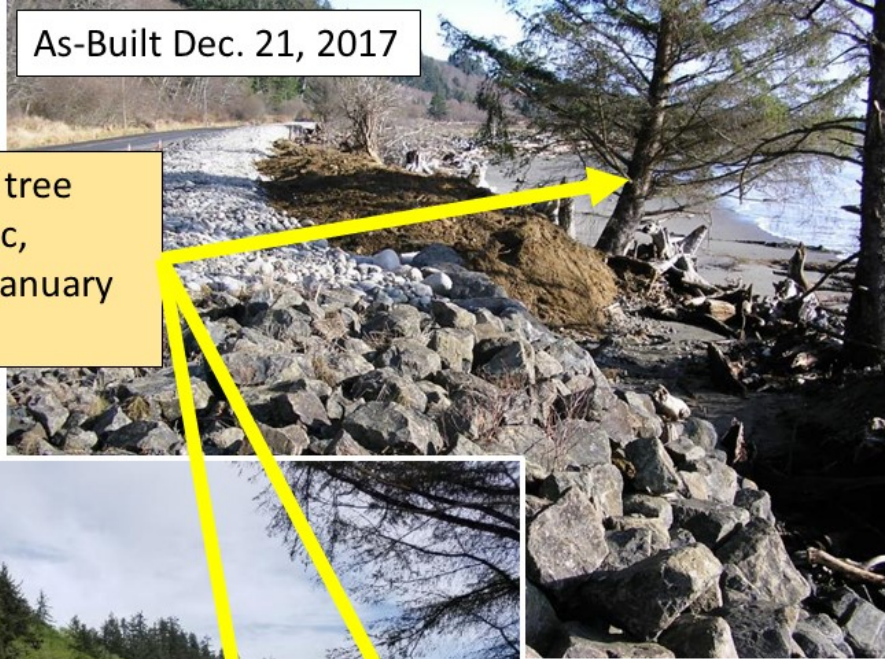
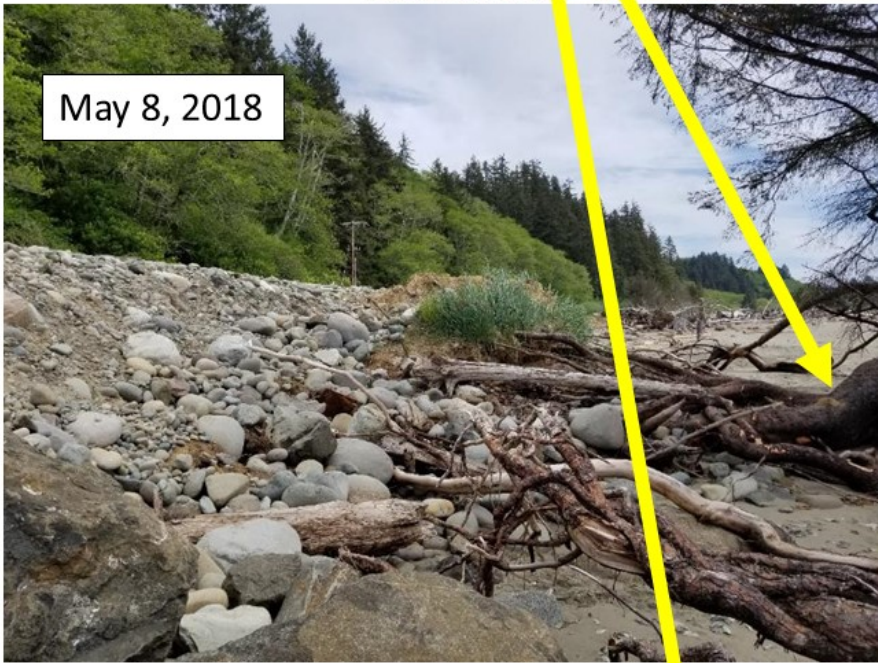
Back side of tree buried in Dec, exposed in January and May
