SR 105 MP 20 Washaway Beach 2019 Dynamic Revetment Monitoring Report

**Rob Schanz PE, LG, Hydrologist
Garrett Jackson LG, Hydrology Program Manager
WSDOT Headquarters Hydraulics Office**

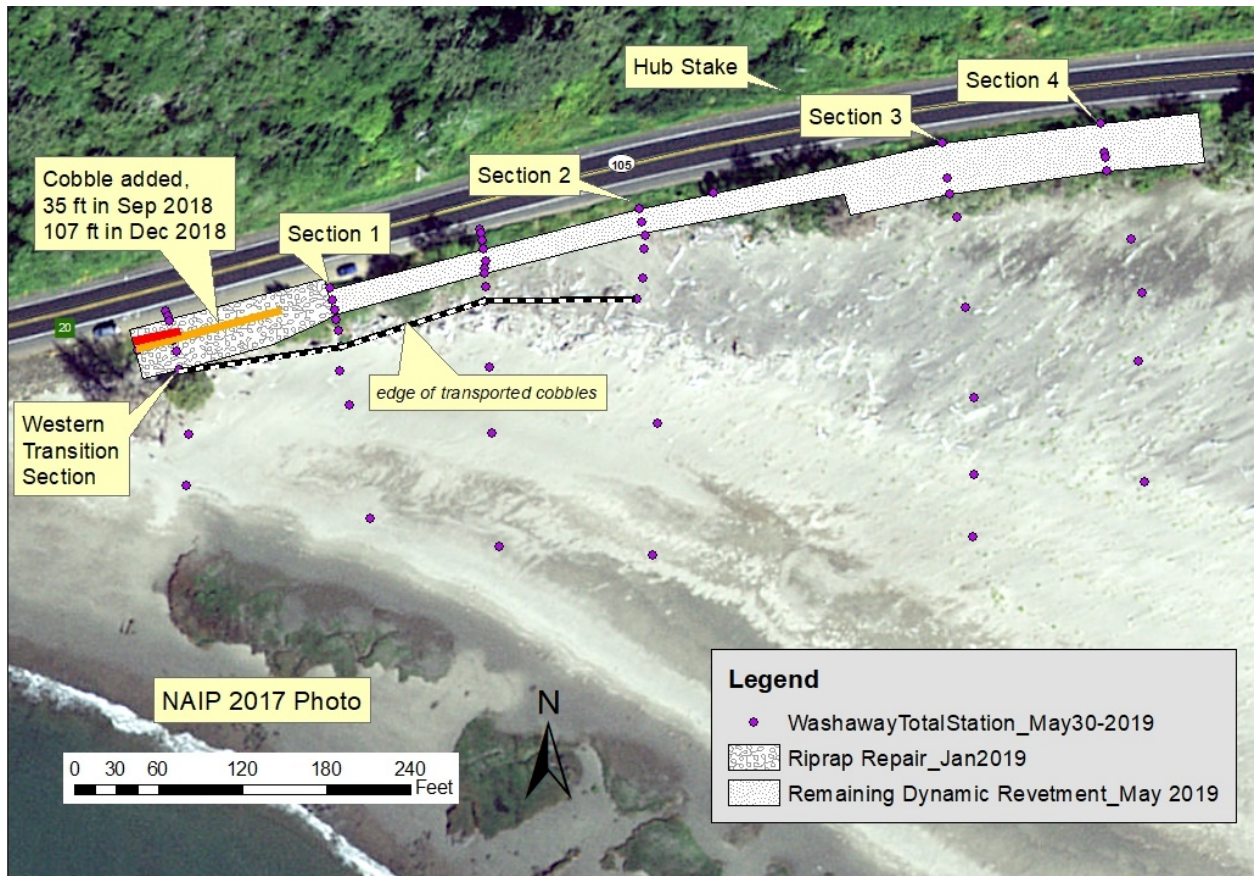
Figure 7. Map of the 2018-19 repairs and May 2019 survey.

Figure 7 shows the locations of repairs constructed in the 2018-2019 storm season, and Figure 8 compares cross sections before and after repairs in the western transition area. On September 11 WSDOT supplemented cobbles in the west transition area based on the recommendation from the 2018 monitoring report to add material where observed wave energy was highest. The main repair area covered about 35 feet of shoreline beginning at the west end of the project. Material was placed using a 12 cubic yard dump truck, end dumping cobbles at the edge of the existing cobble berm. A small excavator then bladed and pushed the material outward to extend the top of the berm. The outer slope was allowed to stabilize at the natural angle of repose without compaction (estimated in the field to be steeper than 1.5:1). The main repair required ten 12 cubic yard loads. Since material was available, WSDOT also used 3 loads (36 cubic yards) to fill a scallop developing on the east side of the planned repair, covering about 30 feet of shoreline.

Maintenance observed major loss of material in this area after two large storms with king tides on December 18 and 20. On December 21 WSDOT placed 220 cubic yards of cobble in a 107-foot length of shore at the west end of the project. This reconstructed a berm top width of 15 feet at the west end, transitioning to tie in to un-supplemented areas to the east at 9 feet wide.

King tides combined with moderate winds on December 22, 23, and 24 continued to erode the new berm material at the west end. By December 25 the berm width in the west transition area had eroded to as narrow as 7 feet. Because of the rapid rate of cobble loss, the observed instability of the berm, and forecasted storms and king tides in early January, WSDOT decided to abandon the cobble berm concept in the west end of the project where storm energy is too high for the narrow berm footprint. An emergency contract was therefore used to replace the cobble with an angular rock revetment on January 1, 2019 (Figure 9). This revetment covered 140 feet of the western end of the original dynamic revetment (Figure 7). Large cobbles pushed to the seaward edge of the rock revetment were used to soften the toe of the treatment, and additional cobbles salvaged from the riprap repair area were used to supplement the transition from the new riprap to the remaining cobble berm sections.

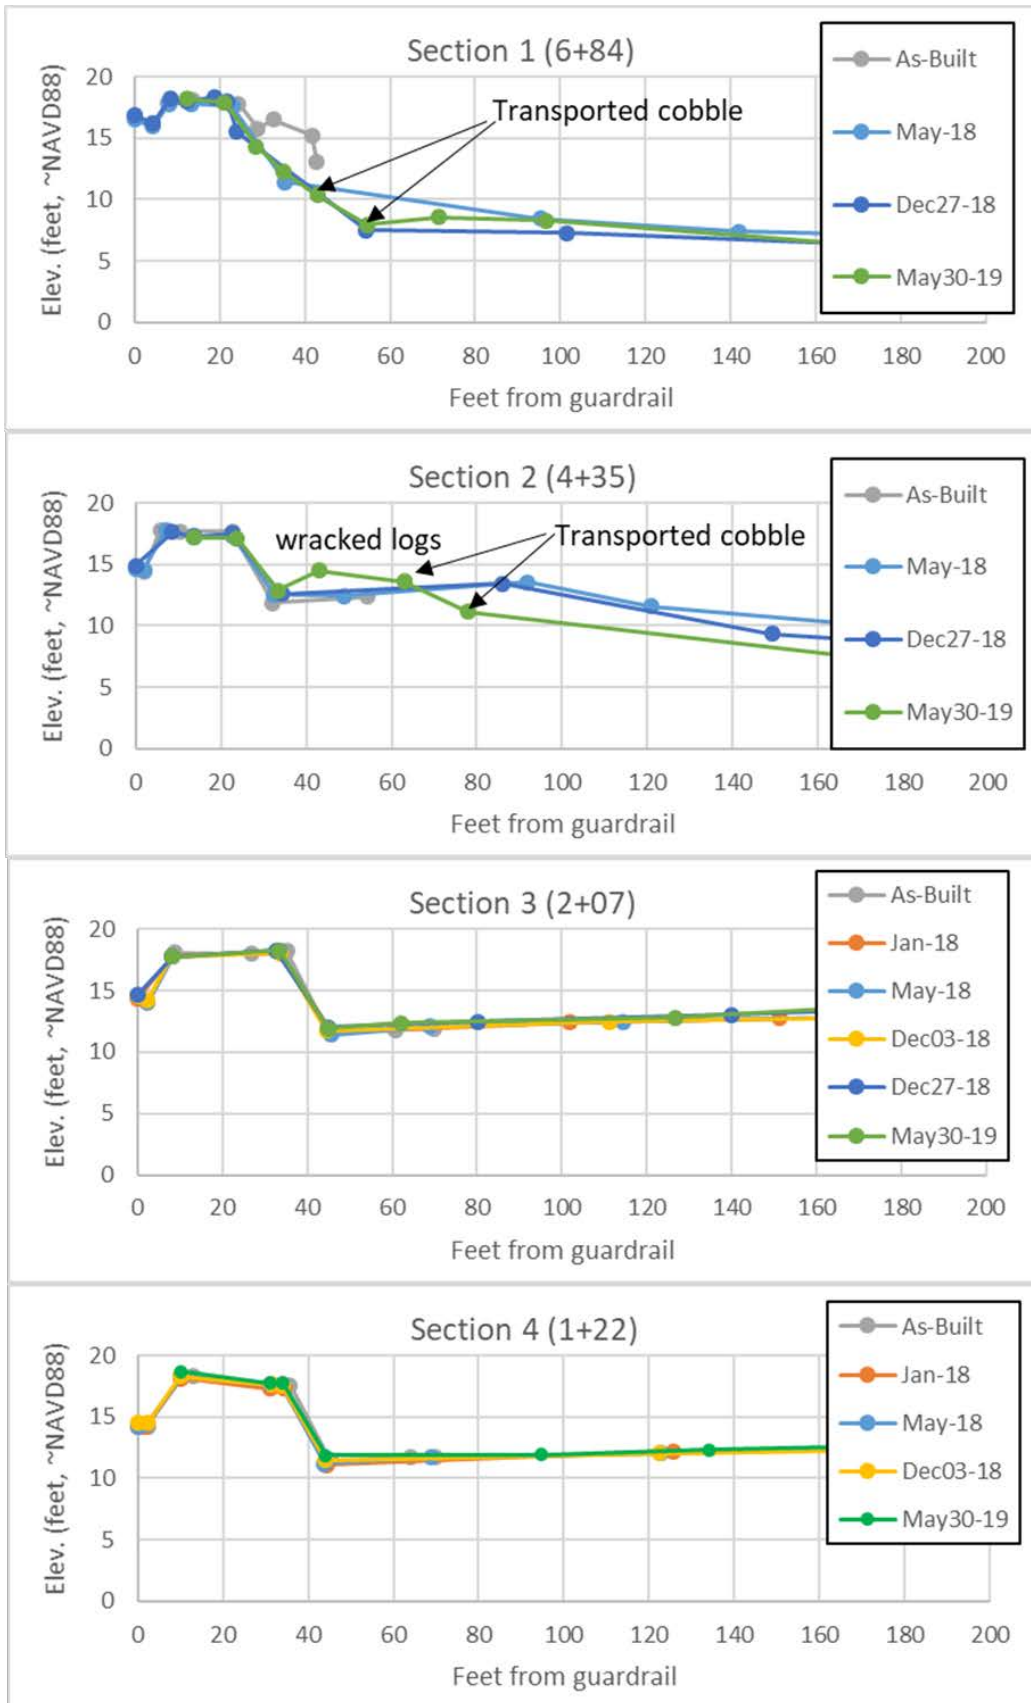
Figure 10 Comparison of transect surveys

Detailed site surveys were performed on December 3, 2018, December 27, 2018, and May 30, 2019. Appendix B compares representative photos from each monitoring season, and Figure 10 compares the transect survey data. Figure 7 shows the transect locations. Most of the dynamic revetment east of Section 2 saw little wave action and has not significantly deformed relative to the As-built condition. Changes in this area are subtle and are likely caused by settlement and shifting of the loose cobble material.

Section 1 is at the west end of the remaining dynamic revetment, near the transition to the January 2019 riprap. The dynamic revetment here was eroded by storms in December 2018 and then supplemented with cobbles as part of the riprap repair. The berm top width is now similar to the original constructed project, but the beach at the toe dropped about two feet after the December storms. The transition slope between the original dynamic revetment toe and the eroded beach is covered by cobbles transported from the west, including cobbles eroded before the riprap placement and cobbles that were left on the face of the riprap repair in January 2019. An arc of transported cobbles continues along the upper edge of the beach to Section 2 where cobbles front a bench of wracked wood (Figure 11). Figure 7 maps the eastward extent of the transported cobbles and Figure 10 shows their location on Sections 1 and 2.

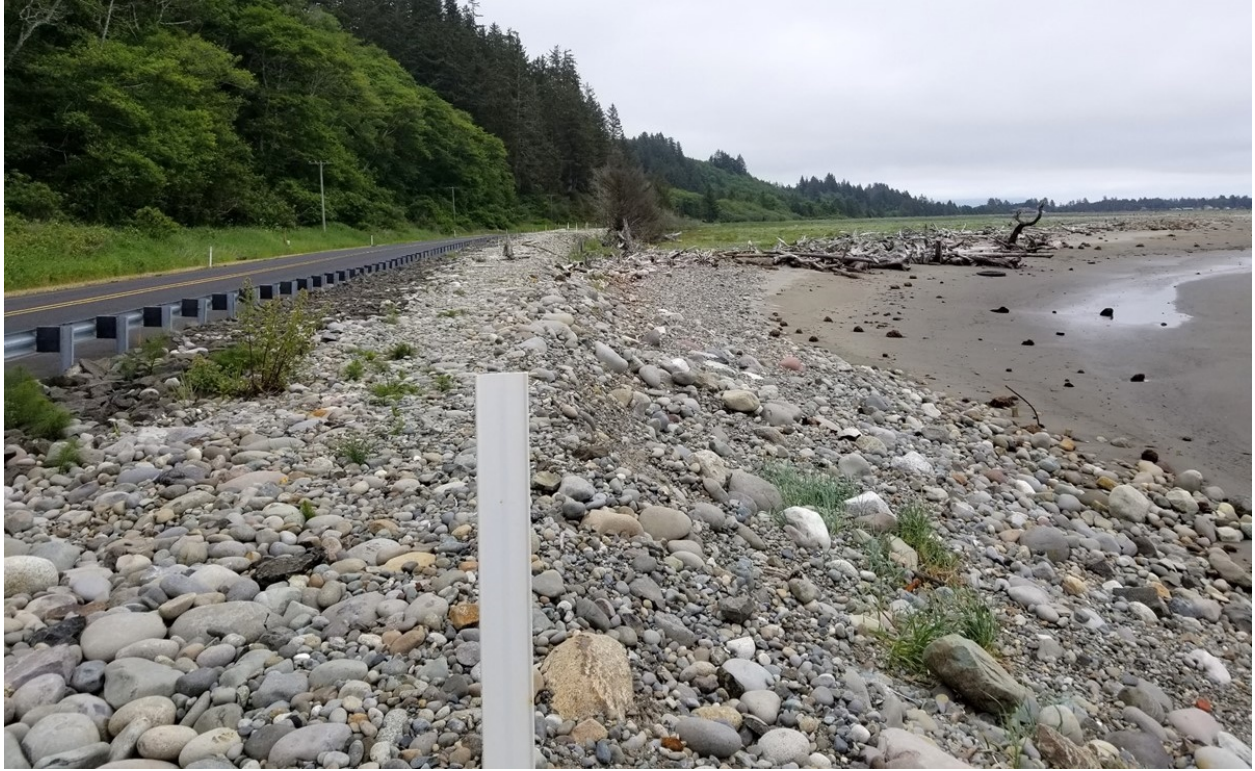
Figure 11. Photo from Section 1 of cobbles transported eastward along the toe of the dynamic revetment.
