Integrating Nature-based Engineering Designs and Adaptive Management Strategies for a Resilient Coast in North Cove, WA

Authors: Hannah Drummond (Washington Department of Ecology), George Kaminsky (Washington Department of Ecology), David Cottrell (Pacific County Drainage District 1), Heather Weiner (Washington Department of Ecology)

This poster was presented at the ASBPA 2021 National Coastal Conference Sept. 28 - Sept. 30.

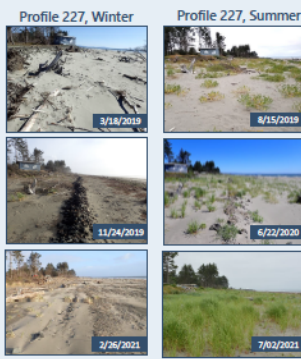
Observations and photo monitoring results show an increase in both the seasonal and overall vegetation, and topographic surveys have shown a dynamically stable position of the revetment toe. The photo series below shows sand accumulation and vegetation establishment between 2018 and spring of 2021 on a selected monitoring profile (profile 227). In the winter photos, notice the burial of the rock berm after it was introduced in November 2019. In the summer photos, notice the change between predominantly seasonal vegetation in 2019 to well-established dune grass in 2021.
