Case Study: Protective Dune

Westport by the Sea Condominiums, Westport, Washington

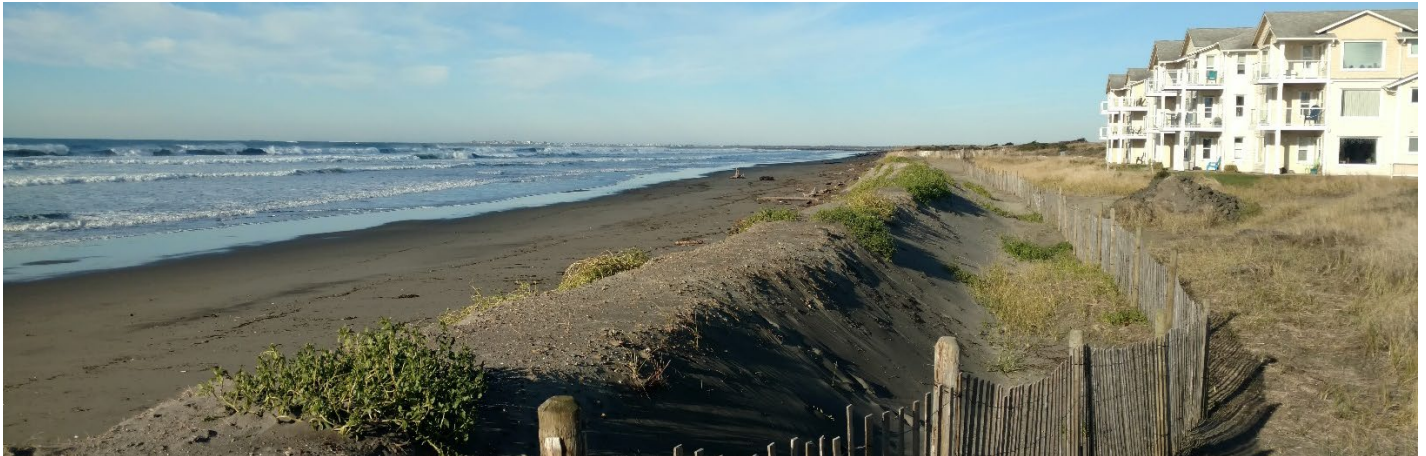
*An artificial dune defends against erosion while sand fencing collects wind-blown sediment.
(Photo credit: Jackson Blalock, The Nature Conservancy)*

The current dune consists of local sand and root-wad logs from Brumfield (local construction company), coir matting (biodegradable coconut fiber) from Ferguson Supply, and cabled logs. American dune grass (*Leymus mollis*) has been planted on top of the dune for stabilization, while American searocket (*Cakile edentula*) has voluntarily taken root and also helped stabilize the dune. The sand fence resides behind the dunes in a zig-zag format to collect windblown sand from the dunes.

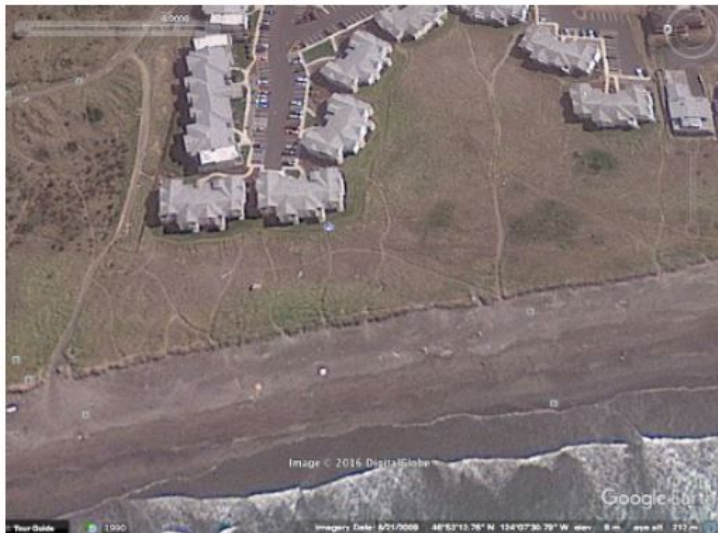
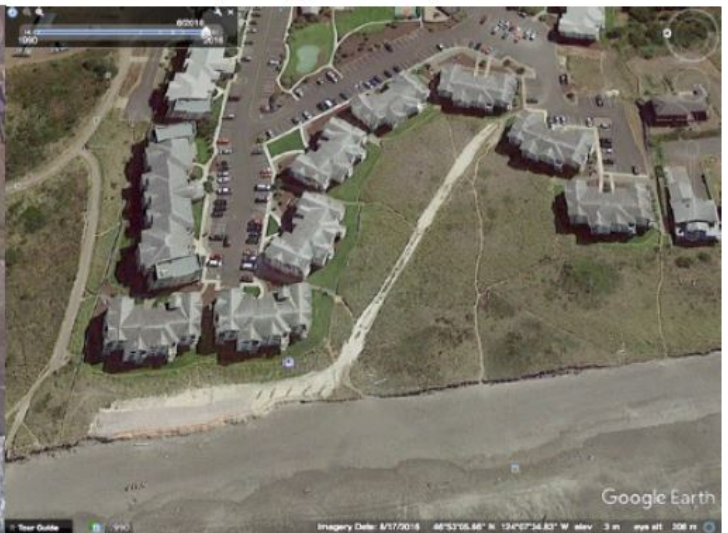
August 8, 2009 ↓

Rapid coastal erosion at Westport by the Sea can be seen in the pictures above. (Image credit: Westport by the Sea Dune Committee's 2017 Report, Google Earth)

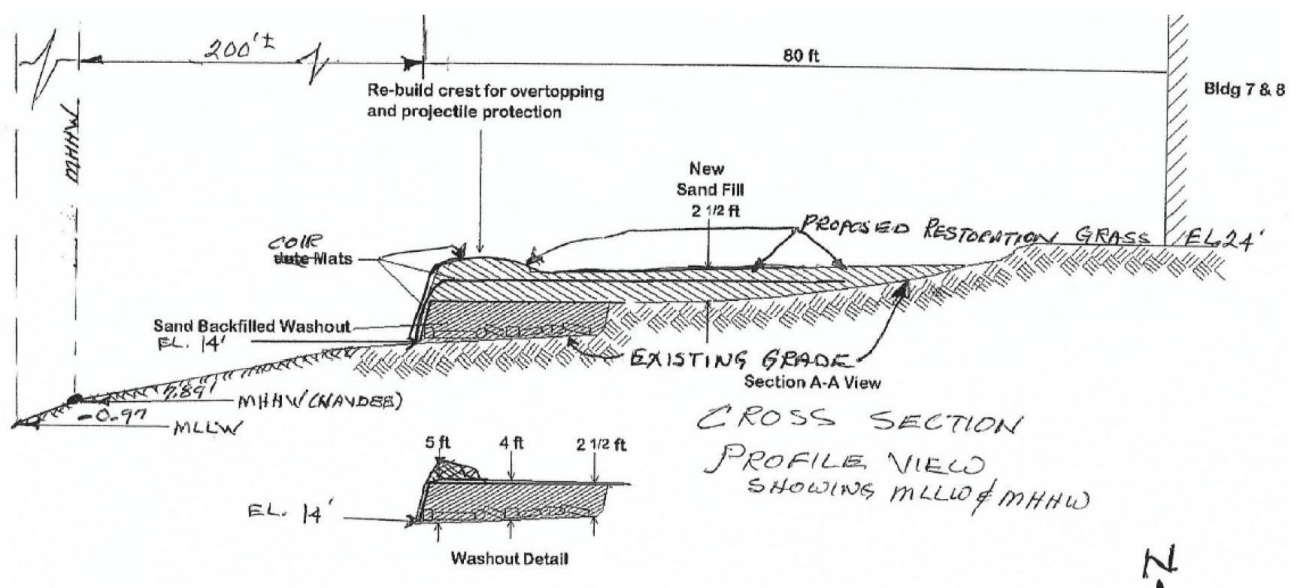
Conceptual sketch of emergency protection measures in place in 2016–2017, in response to severe dune erosion in 2015 and 2016. (Image credit: Golder Associates 2017 Conceptual Mitigation Options report)

Prior to the implementation of the project, homeowners formed a Dune Committee that researched adaptation options, recorded shoreline changes, and provided recommendations on how to approach the coastal erosion threat. The committee met throughout 2016–2017 and recommended a cobble design (see technical documents). However, differences in opinions between Westport by the Sea's two homeowner associations and the dune committee led to a revised approach. After a new engineer was hired, the Westport by the Sea homeowners associations implemented an artificial dune and a sand fence to address erosion. The dune and sand fence are the latest effort in a series of shoreline stabilization experiments, which have involved anchoring wood, adding local sand to replenish the lost sand, adding hay bales, and other soft shoreline armoring techniques.

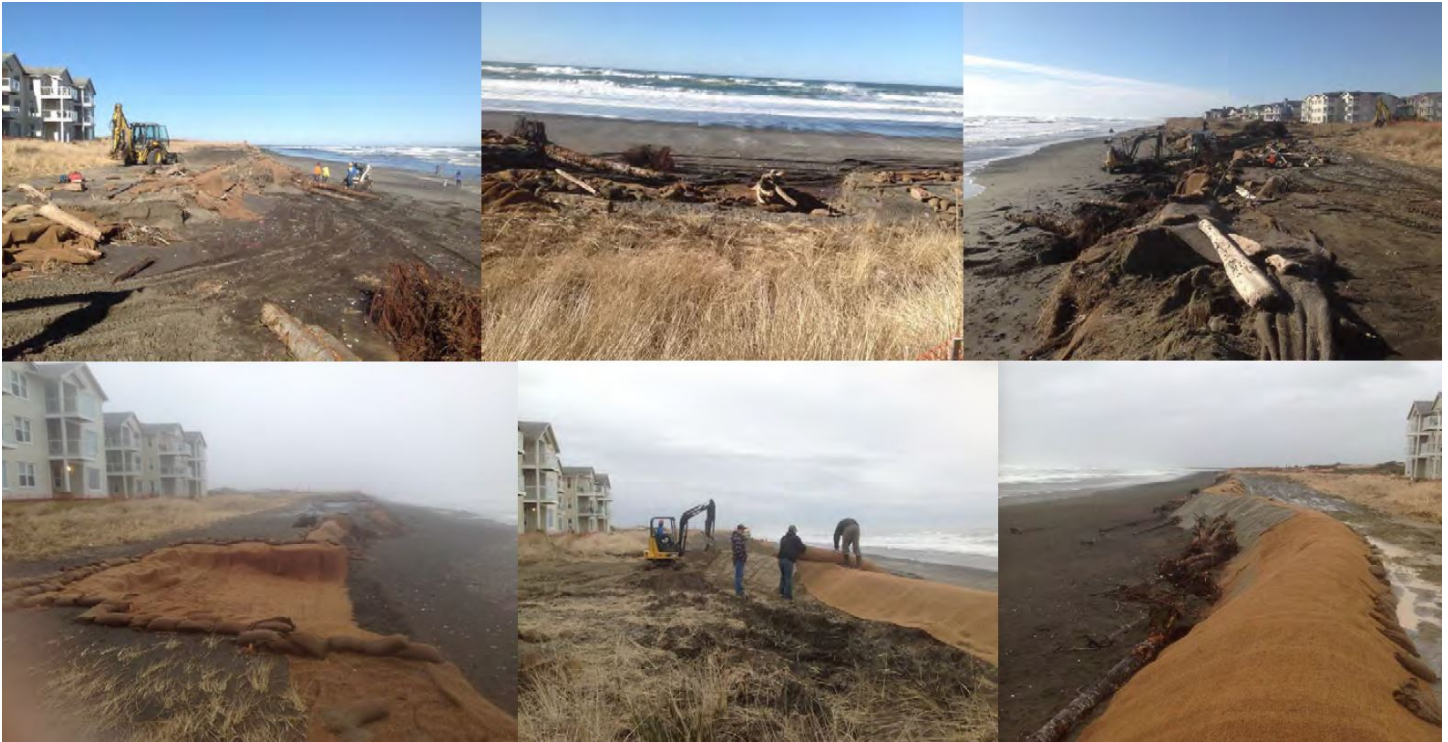
Emergency protection measures with coir mat on the seaward face of the eroding dune, 2017. Sand had been placed atop coir mat and straw bales in 2016. (Image credit: 2018 Homeowners Associations presentation to Washington State Department of Ecology)

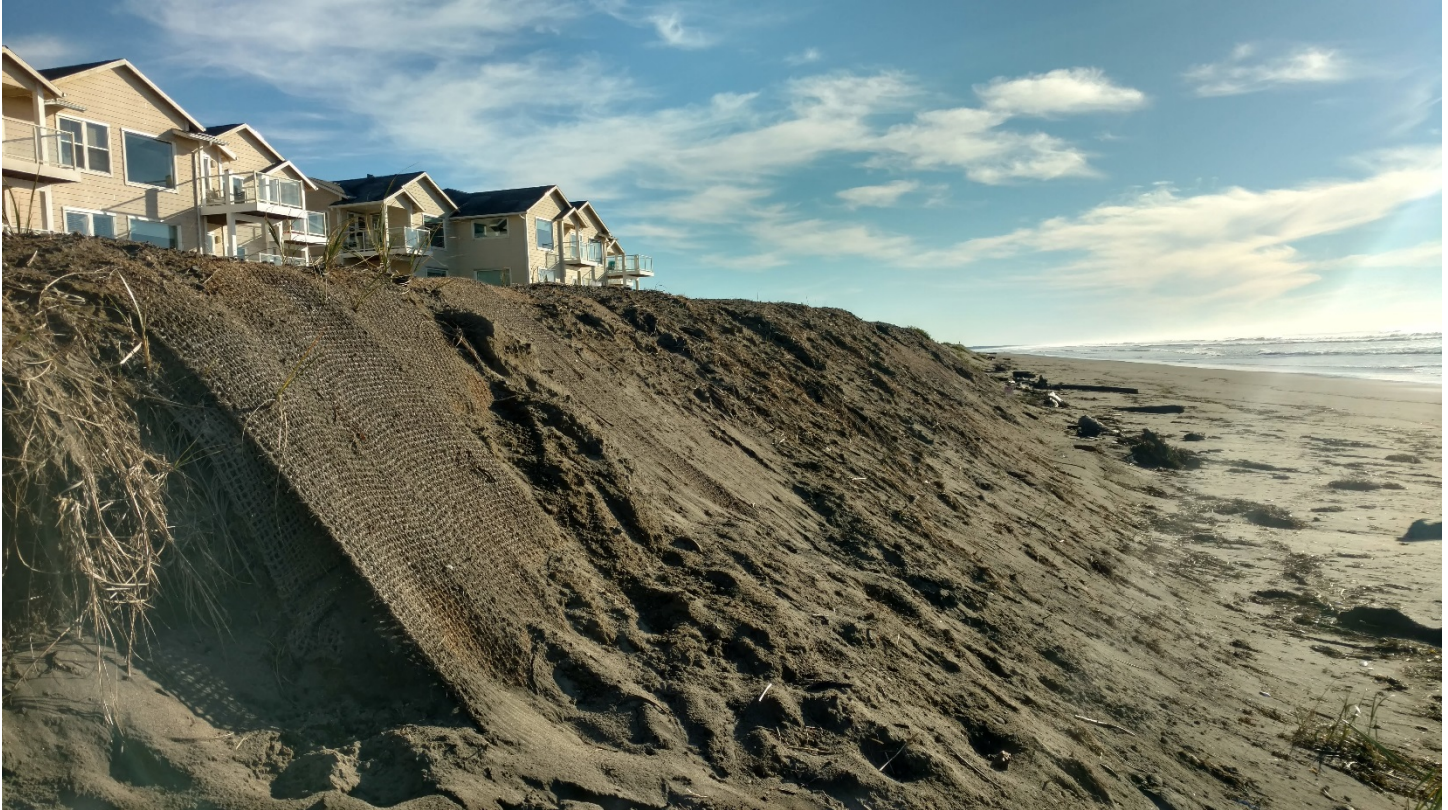
After years of back-and-forth erosion and emergency repairs, Westport by the Sea’s artificial dune is covered with sand (some mechanically deposited, some deposited by wind). Note exposed coir matting (right). (Photot credit: Jackson Blalock, The Nature Conservancy)

As this project is regularly adapted to changing conditions, the homeowners and their contractor have maintained a vehicle access route to the dune in order to make swift repairs. Materials, such as coir matting, are kept on-site to aid with quick adjustments and fixes to breaches in the dune.

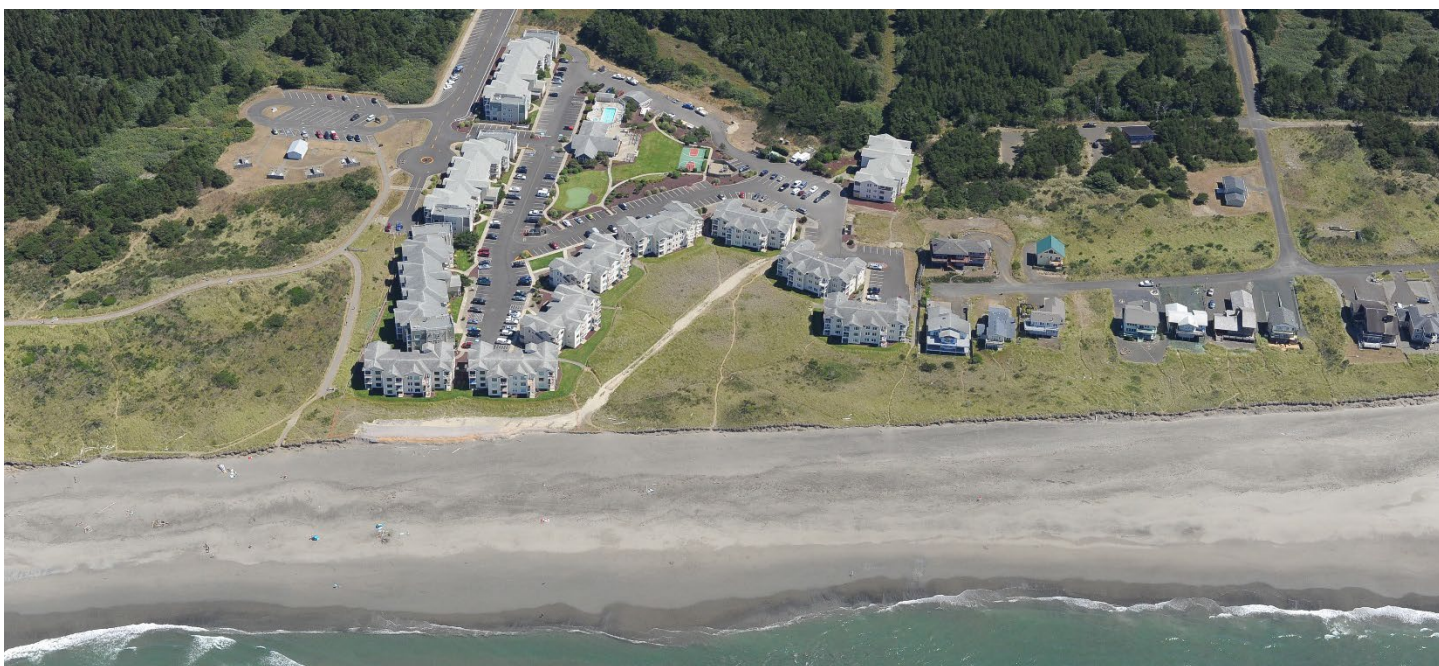
Access route for repairs and continued erosion management is visible as a sandy line between the parking lot and artificial dune. This road has been relocated, but remains in use for adaptation activity. (Photo credit: Washington State Department of Ecology's Coastal Atlas)
