# **Analysis of Options for Maintaining SR 105 near Washaway Beach**

**Jim Park, Senior Hydrologist**  
**Garrett Jackson, Hydrologist**  
**Rob Schanz, Hydrologist**  
**WSDOT Environmental Services**  
**Hydrology Program**

**July 2015**

**Washington State Department of Transportation**  
Environmental and Engineering Service Center  
Environmental Services Office

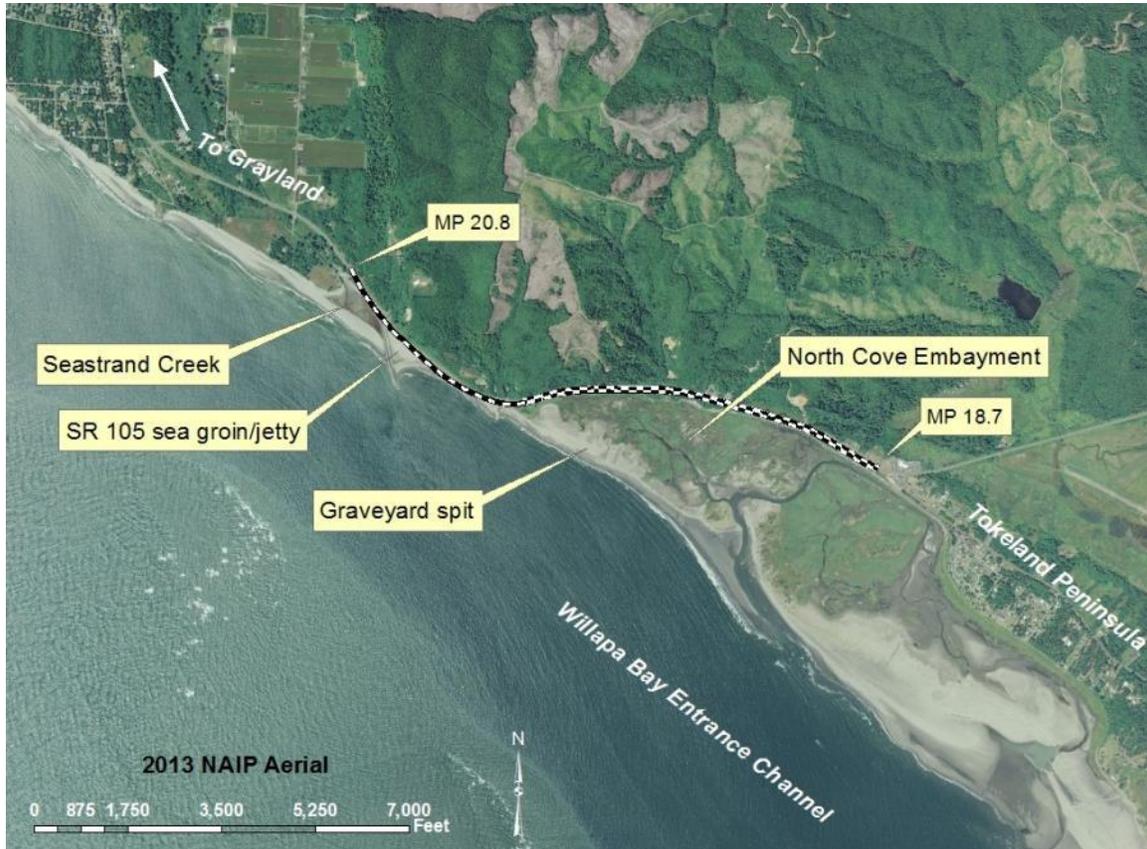
**Figure ES-1. Segment of SR 105 evaluated in this report.**

This report analyzes the coastal processes that are threatening SR 105 between Mileposts (MP) 18.7 and 20.8 at Washaway Beach (Figure ES-1), and evaluates options for dealing with future threats to the highway. Options are evaluated at a conceptual level to compare relative performance from a hydrodynamic and geomorphic perspective. This information is then used to identify which options should be further evaluated for engineering feasibility, cost effectiveness, socioeconomic impacts, and environmental impacts. Key findings and recommendations are summarized below.

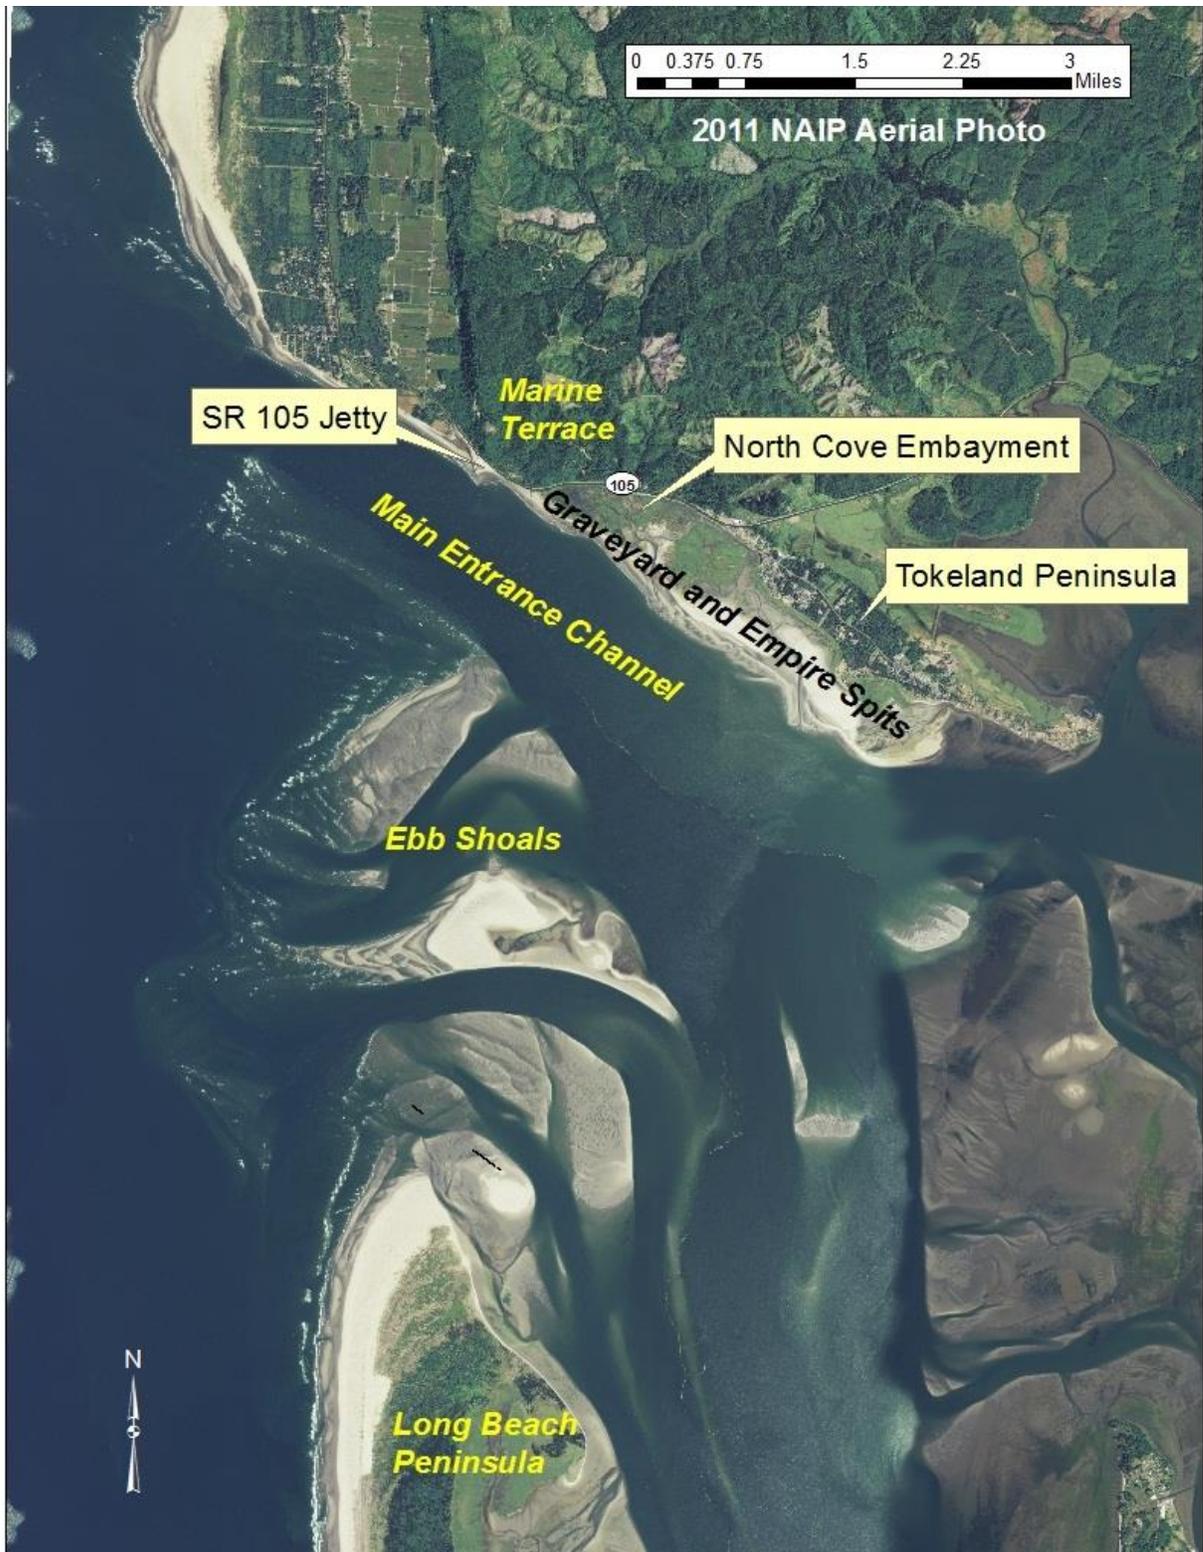
Figure 2. Current configuration of the Willapa Bay entrance channel.

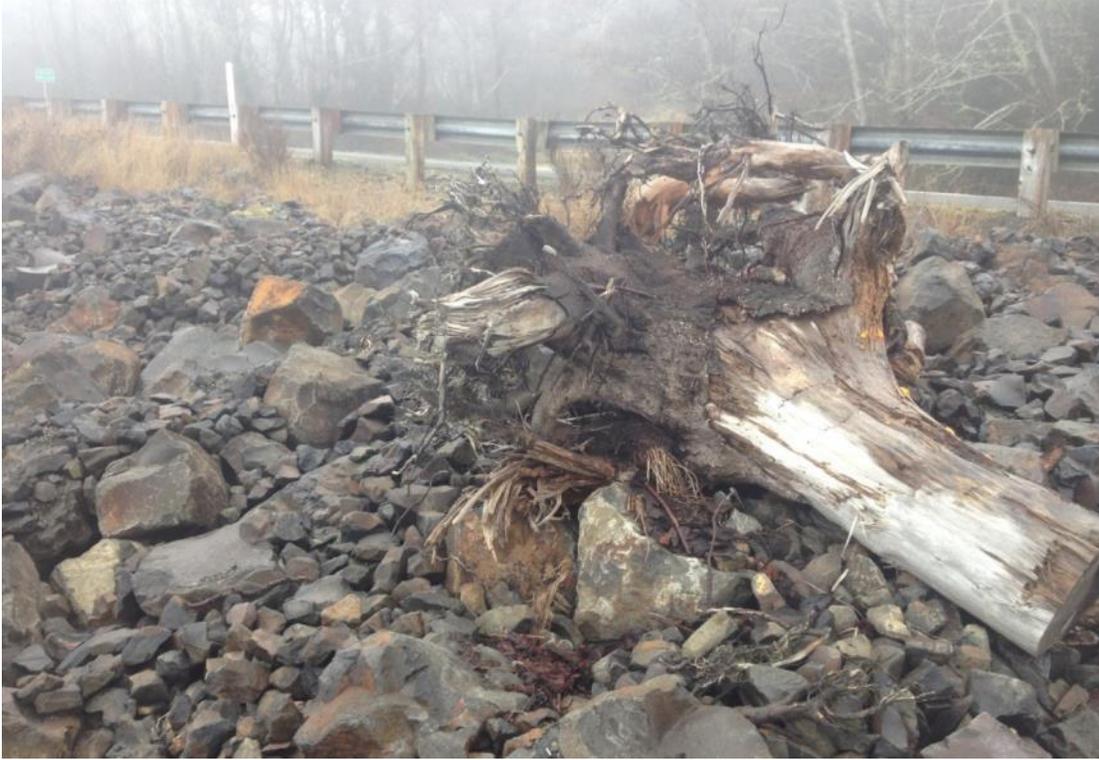
**Figure 5. Debris on top of the roadway embankment, indicating recent wave heights.**

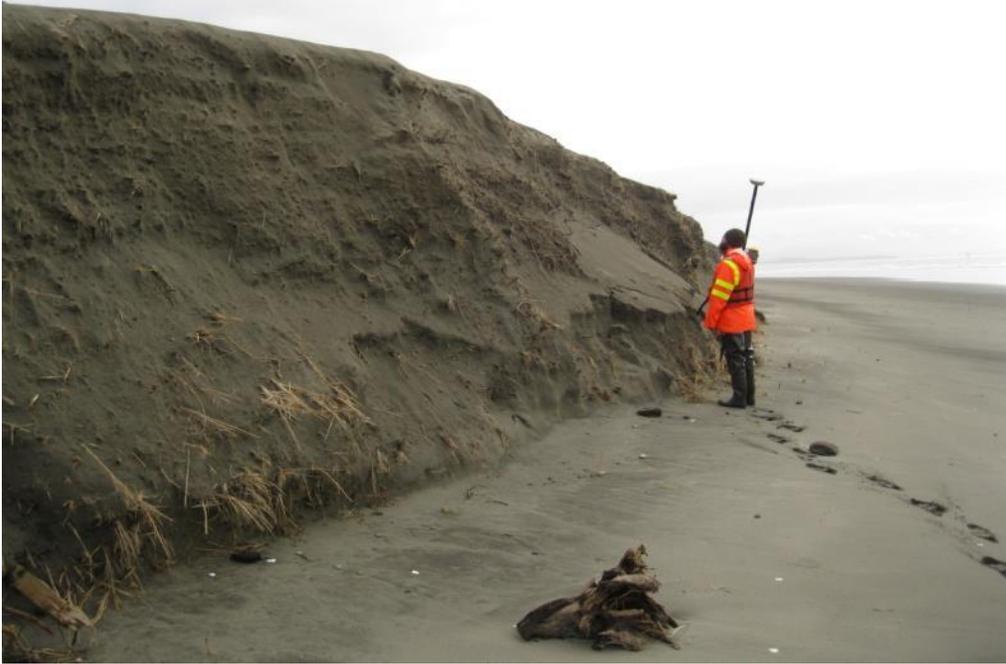
**Figure 8. Erosion at the north end of the constructed dune, February 2014.**

Although the planned length was 12,500 feet, a site visit in February of 2014 indicated that the constructed length was significantly shorter - approximately 2000 feet shorter on the south end and a thousand feet shorter on the north end. Also, it was noted that significant portions of the north and south ends of the constructed dune have been eroded by waves. Figures 8 and 9 show selected views of the erosion. Erosion has truncated the dune further, and eroded the terrace underneath the dune. In addition, the crest of the dune is lowering in place through wind erosion (Figure 10). Scallops created by wind erosion, similar to that shown in Figure 10, occur on average every 80 feet on the southern half of the dune. They are less frequently spaced on the northern half of the dune. Based on the fluvial and aerial erosion, the replenishment rate needed to maintain the constructed configuration of the dune may be greater than the Corps of Engineer's estimate for replenishment.

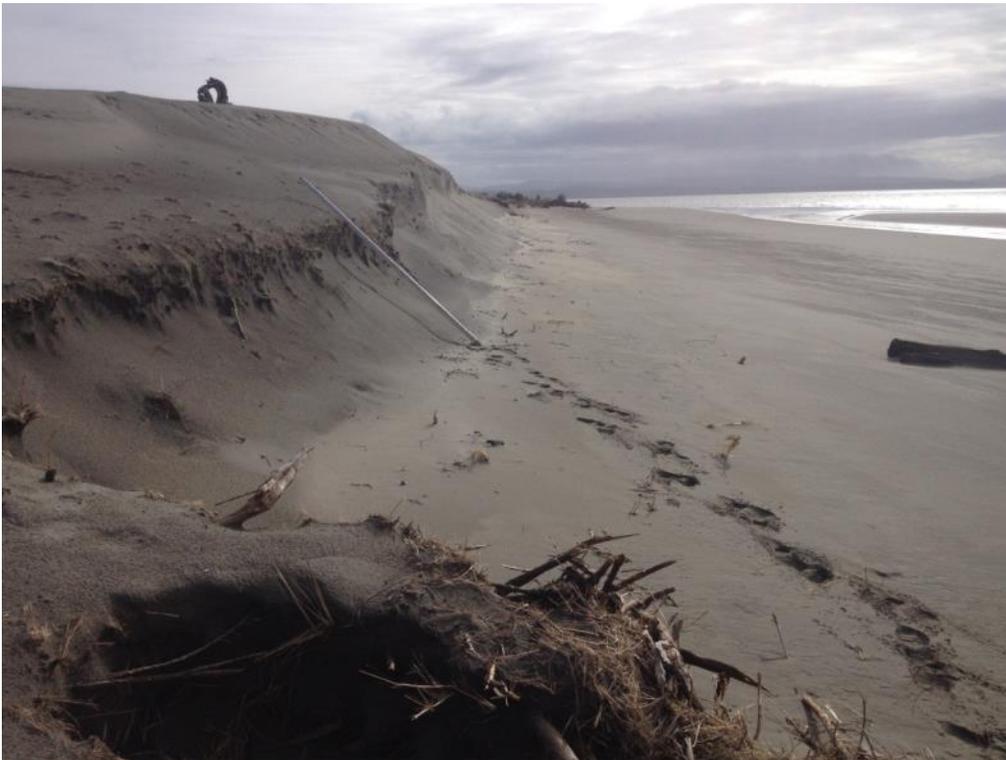
**Figure 9. Erosion at the south end of the constructed dune, February 2014.**

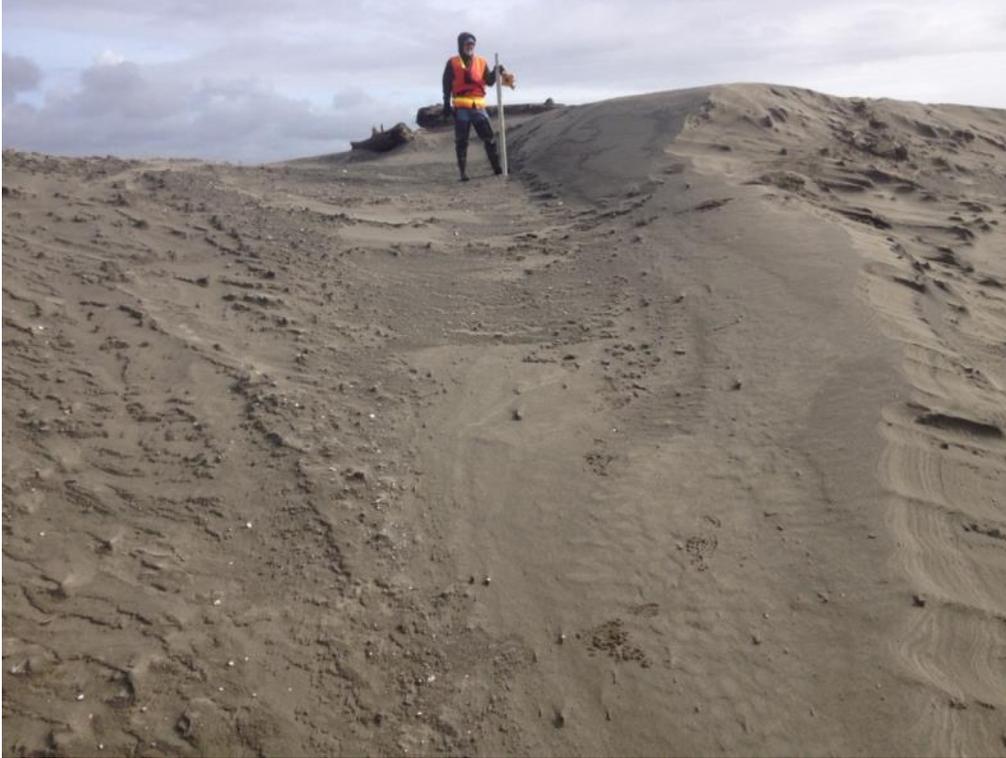
**Figure 10. Typical wind eroded scallop at crest of the constructed dune. The rod shown is approximately 4 feet in height.**

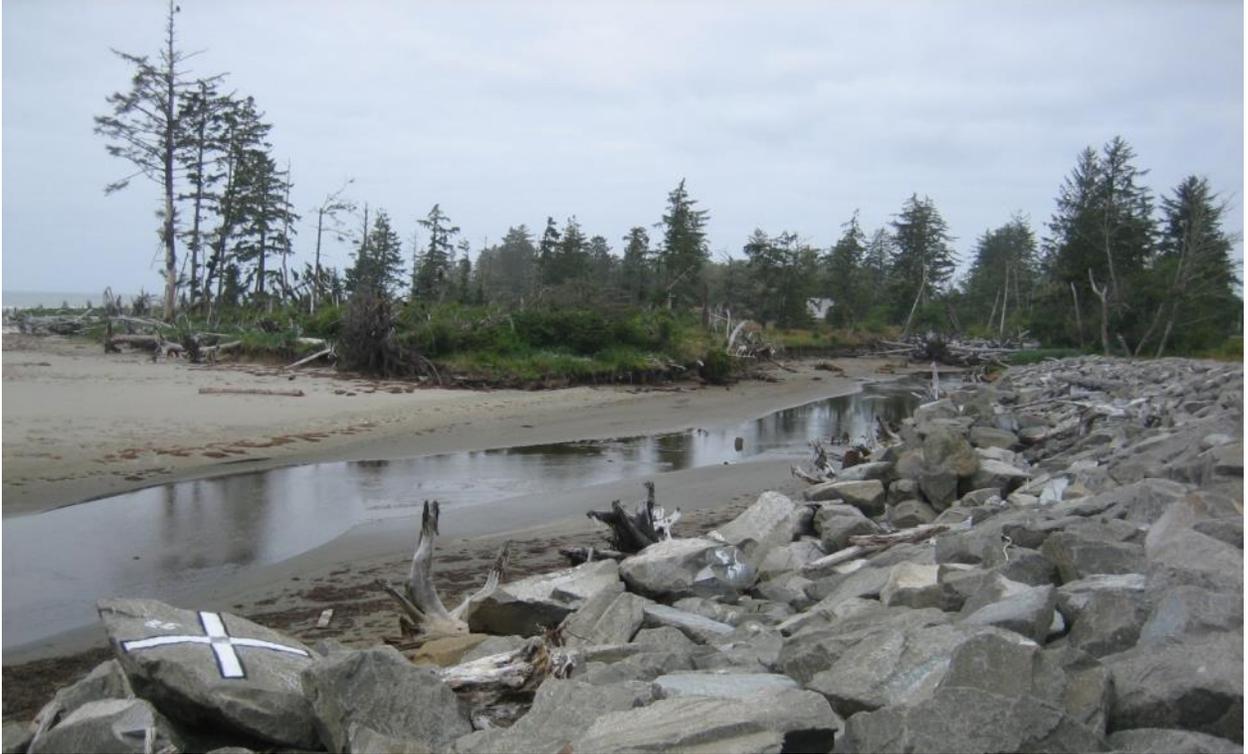
**Figure 14. Photo of the 2006 revetment with log energy dissipators northwest of the jetty along Seastrand Creek.**

During the winter of 2005-06 waves eroded large sections of shoreline located to the southeast of the groin. The dune line of the backshore was breached, and destruction of SR 105 was narrowly averted by emergency action. A sloping rock revetment with buried toe logs was placed at this time, starting at the south end of the 1996 shoreline armor. These storms also undermined 600 feet of the SR 105 embankment immediately northwest of the groin near the mouth of Seastrand Creek. A revetment was installed here in the summer/fall of 2006, consisting of large rock armor fronted by energy dissipaters made up of boulder piles and large rootwads (Figure 14).

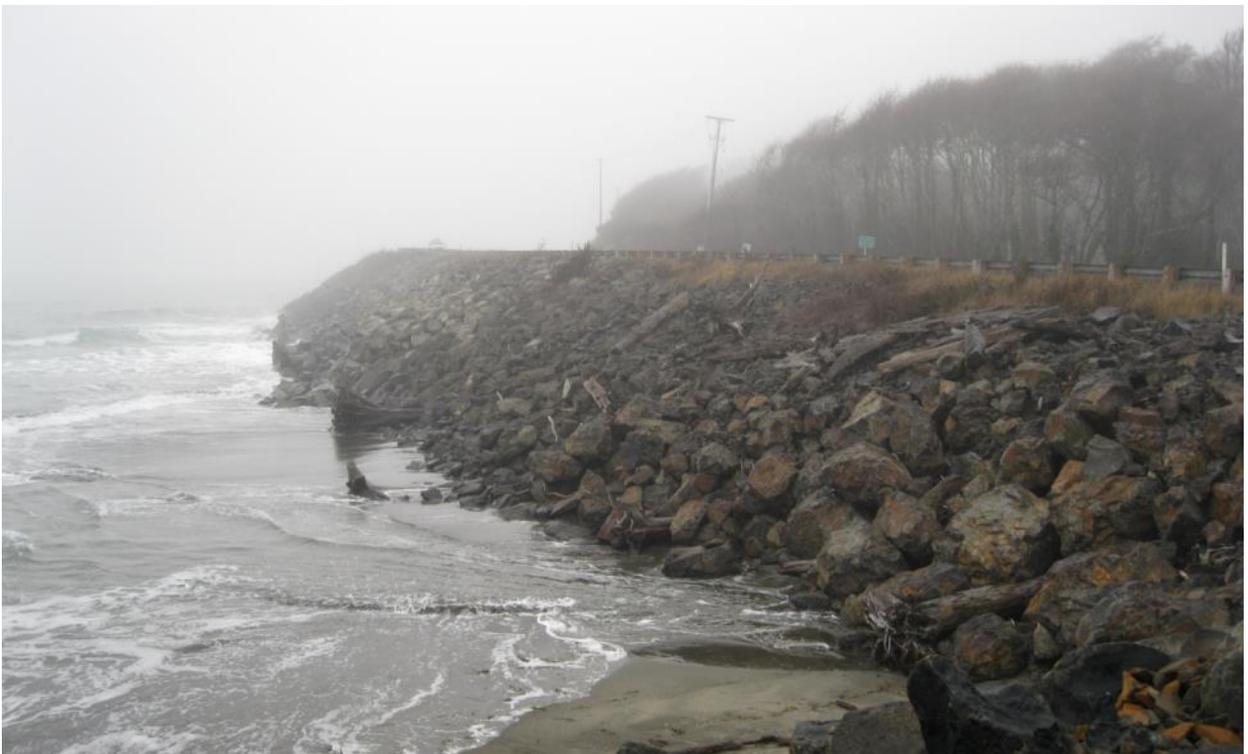
**Figure 15. Photo of typical emergency repairs southeast of the jetty.**

Between 2009 and 2014 erosion progressed steadily along the exposed shore southeast of the 1996 and 2006 repairs, requiring emergency repairs on at least four occasions. These have generally consisted of sloping rock revetments with buried toe logs to deflect energy

(Figure 15). Early season storms in October 2014 further eroded the shore at the point where SR 105 bends east into the North Cove embayment, necessitating a 320-foot-long emergency repair (Figure 12).

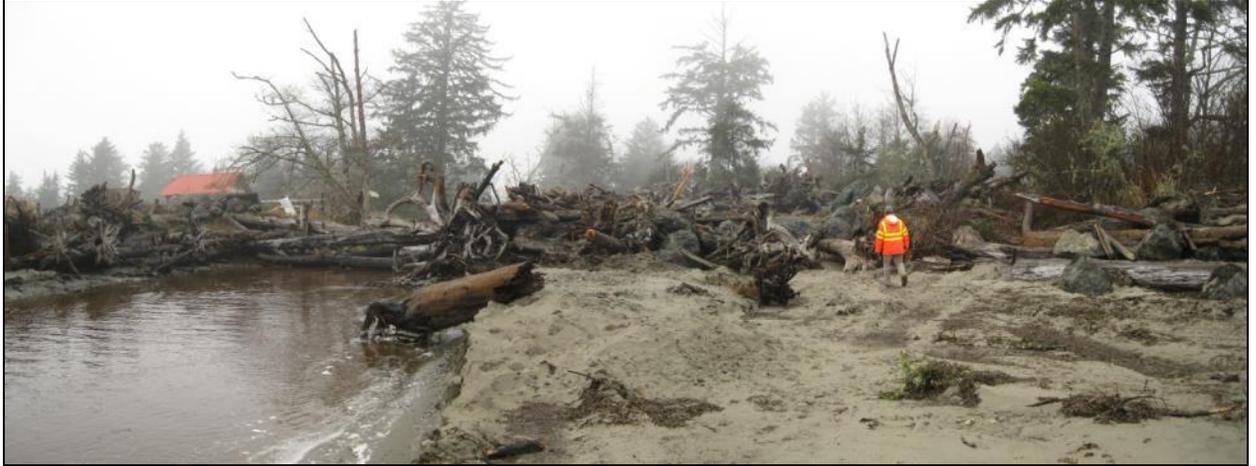
**Figure 16. Log structure constructed by the diking district across the mouth of Seastrand Creek in 2013.**

Erosion in the winter of 2013 created a scarp along the left bank of Seastrand Creek near the mouth. This is now threatening to flank the existing log and rock revetment. This erosion may have been exacerbated by removal of logs from Seastrand Creek by the local diking district in 2012. A repair to stabilize this segment is currently in design, and will be similar to adjacent revetments. The diking district has also constructed a log barrier across the mouth of Seastrand Creek, presumably to limit the progression of erosion and logs up into the creek where it drains cranberry operations (Figure 16).

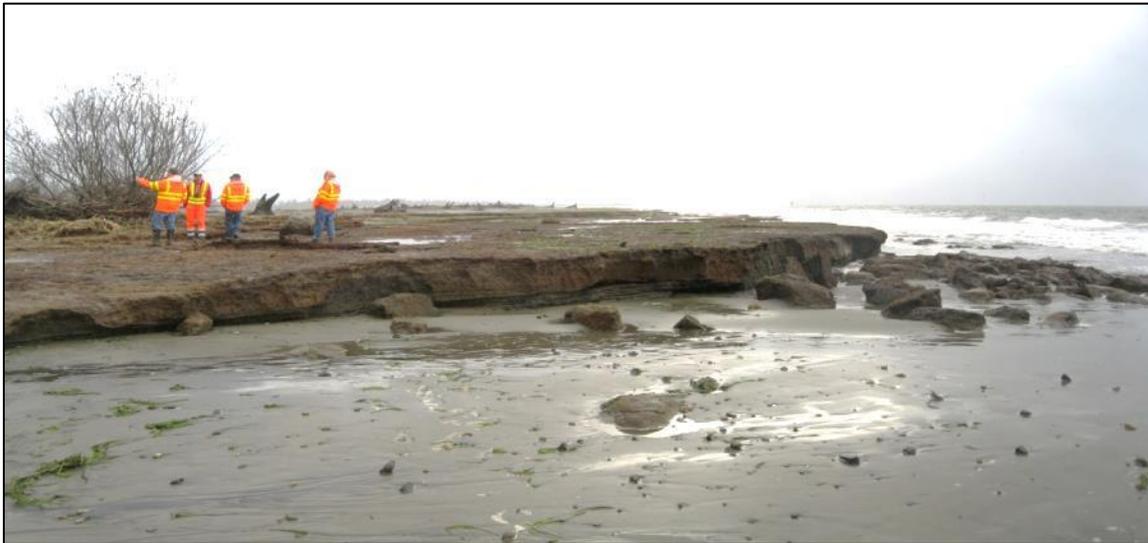
**Figure 17. Exposed terrace and marsh deposits on the margins of the North Cove embayment.**

Even if the thalweg has ceased its northward migration, the channel continues to degrade and widen along its northern margin in response to wave erosion. This wave action has exposed and undermined terrace deposits that were once buried by dunes in the North Cove embayment (Figure 17). This contributes to the loss of beaches and dunes that buffer the embayment from waves, and will likely lead to a more severe wave climate on the North Cove embayment shoreline.

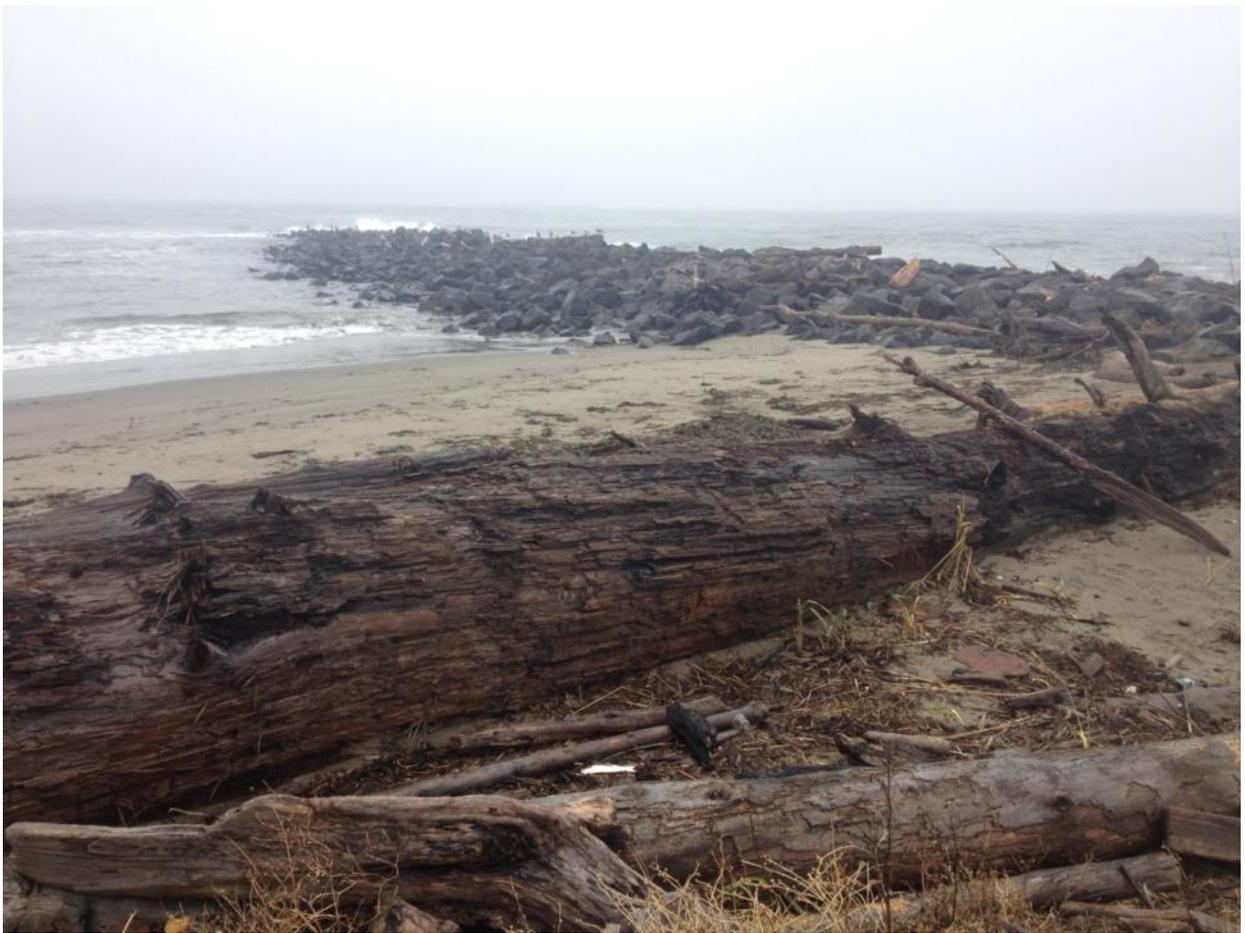
**Figure 23. Current state of a portion of the groin, December 2013.**

In addition, the cross-section shape appears to have changed, becoming flatter, with considerable dislodgement of rocks on the southeast side (Figure 23). The slope on the southeast side appears to be steeper than 1:7. While sand was used to fill the void spaces on the southeast side of the groin, and gravel on the northwest, neither can be observed today.

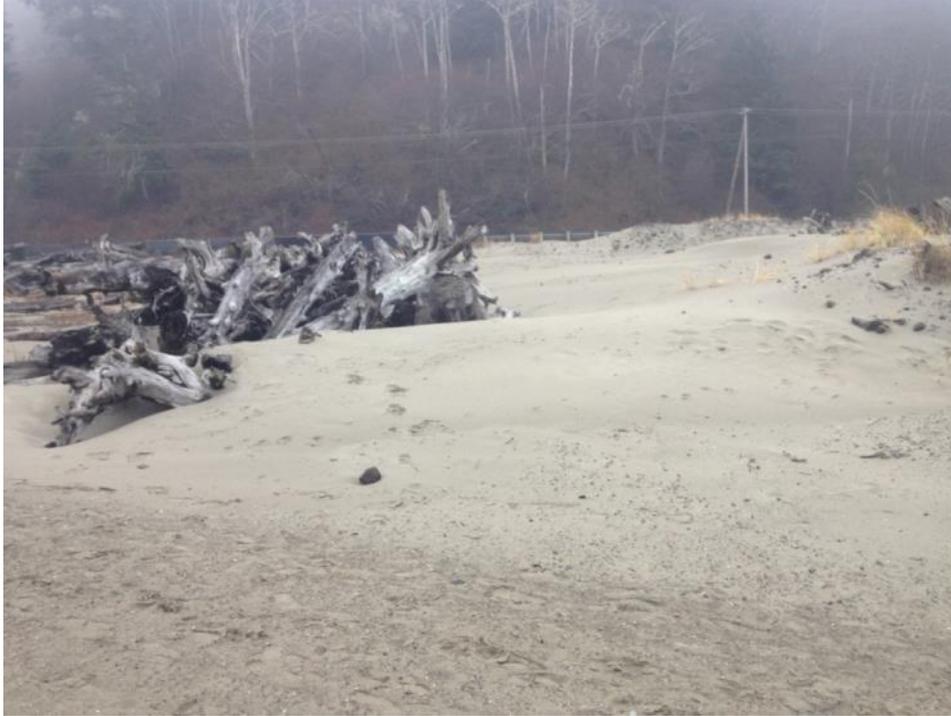
**Figure 28. Wood debris placed on beach nourishment area to slow wind erosion.**

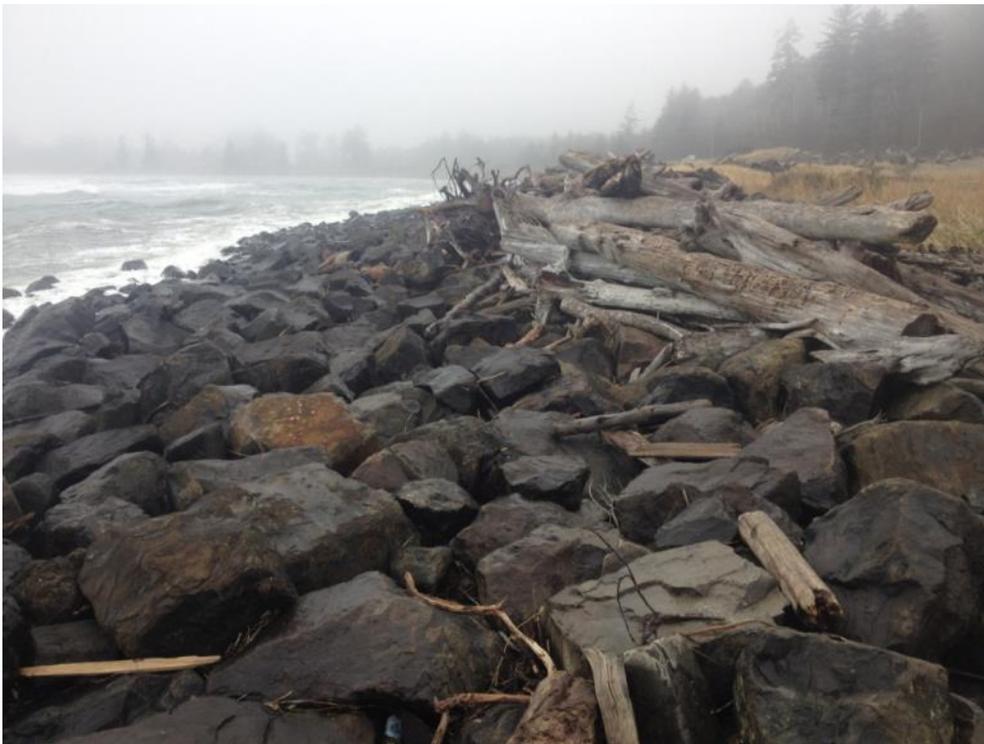
**Figure 29. Section of rip rap added east of the groin/beach nourishment area.**

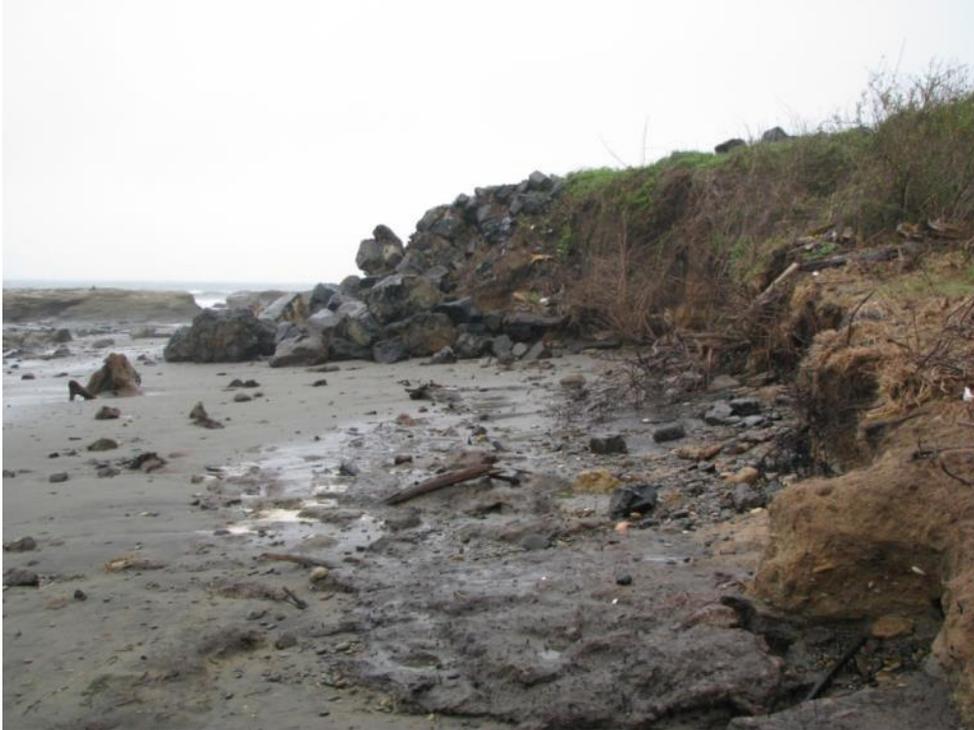
**Figure 30. Undermining of rip rap and erosion east of the emergency stabilization project.**

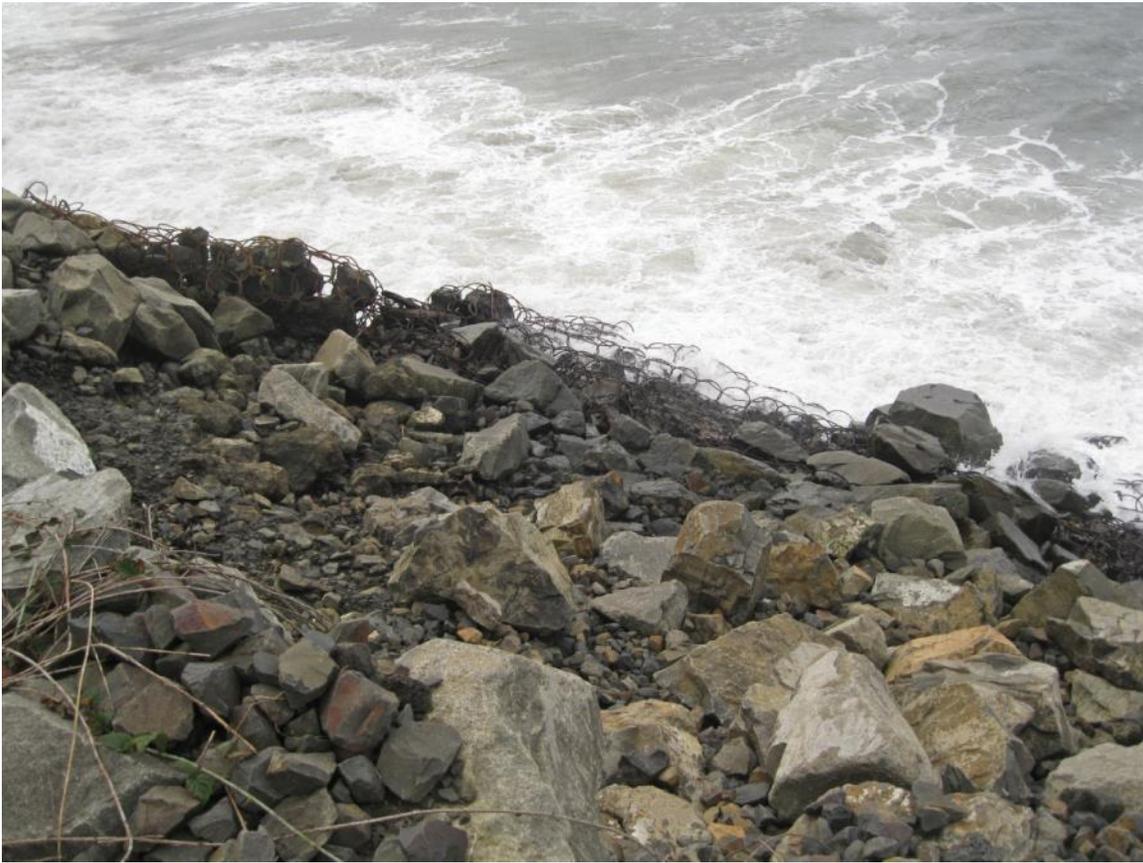
**Figure 37. Failure of submarine netting and armor just south of the jetty.**

Older portions of shoreline armor constructed just south of the groin/jetty are beginning to fail as they are exposed to more severe wave action (Figures 34 and 37). These segments were constructed in 1996 with rolls of rock wrapped in steel submarine netting supported by a rock toe. Wave action has undermined the rock toe, causing large segments of the submarine netting to rotate downslope. This has created an exposed scarp where the netting has pulled away from the top of the slope. An emergency rock repair was placed in November 2014 on one 165-foot segment of the net-wrapped armor, and another 200-foot segment will be repaired in 2015. Another 800 feet of this armor is still vulnerable but has not yet warranted an emergency repair. All of the armored shoreline faces a severe wave climate and will require continual maintenance to protect the highway.

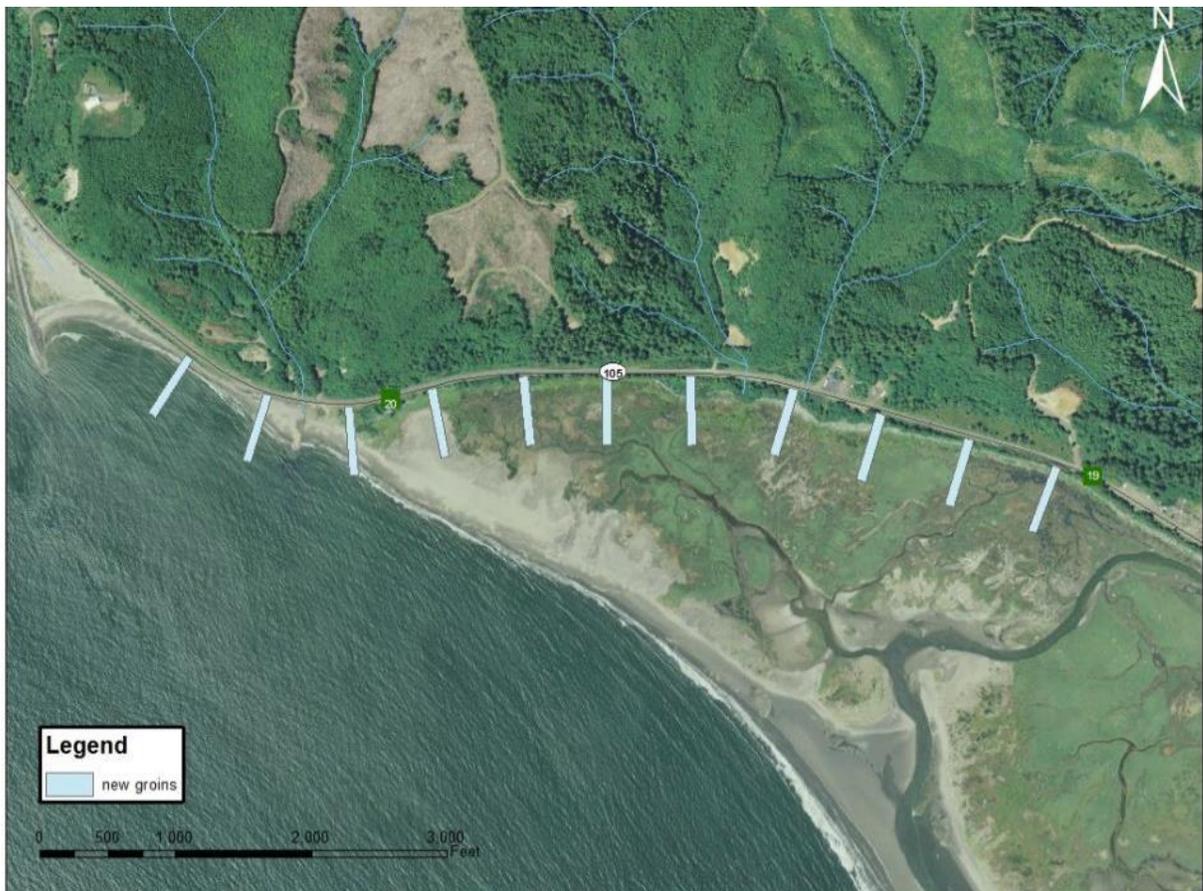
Figure 43. Possible groin configuration for SR105 at North Cove/Washaway Beach.

The locations of any additional groins would need to be modeled to achieve the most effective combination of shear stress reduction (by deflecting current) and least environmental impact. The groins described in the 1997 environmental assessment had an aerial impact of 28 acres of subtidal area, and 2 acres of intertidal habitat. The groins shown in Figure 43 would directly impact 8.6 acres. Beach nourishment and indirect and temporary impacts could total an additional 15 acres. Note however that this option would not address the potential flooding of the lower elevation portions of SR105, but would redirect flow away from the highway embankment. East of the existing groin, the new groins would be installed in anticipation of continued shoreline retreat into North Cove.

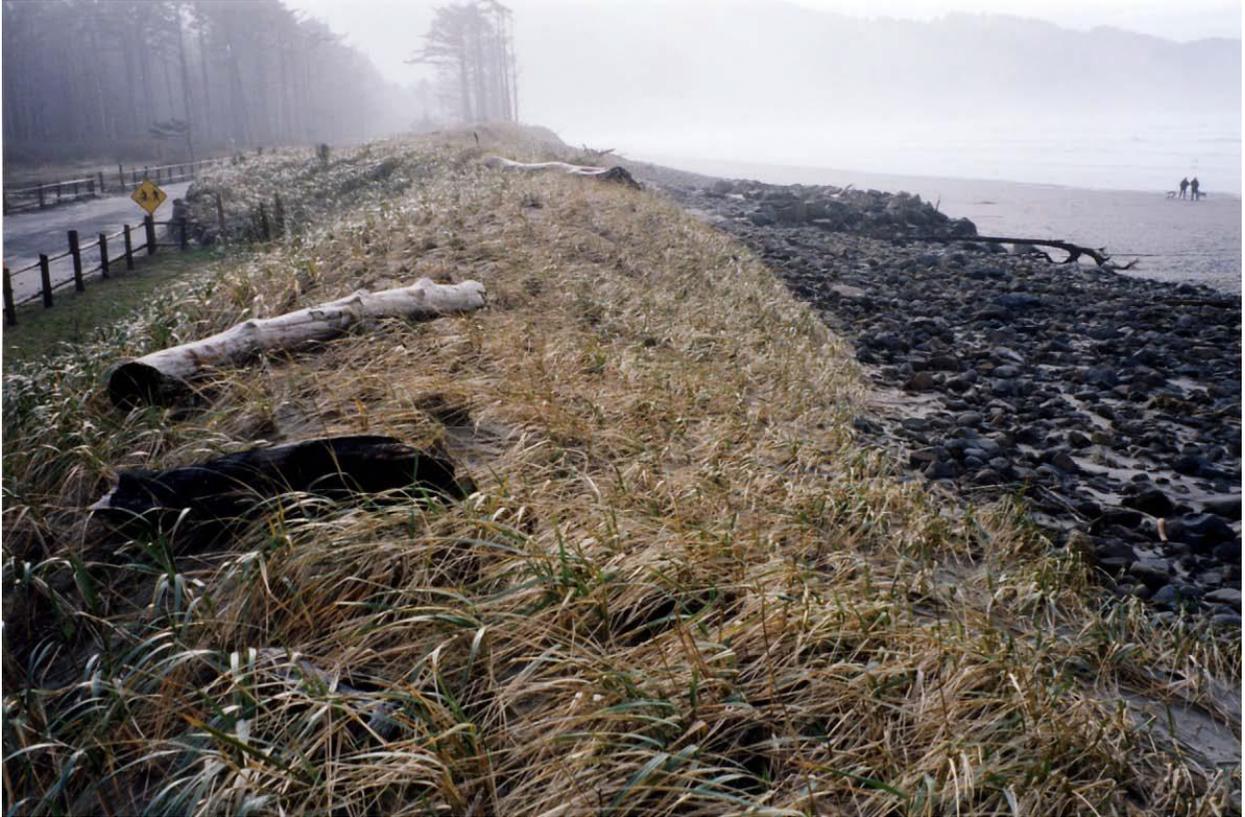
**Figure 45. Cobble berm (dynamic revetment) with artificial dune, Cape Lookout State Park, Oregon (2009).**

impact. We would expect a project life of 30 years, with some maintenance – addition of cobbles – every 10-15 years. This option would not protect the lower areas of the highway from occasional flooding during extreme high tide events. However, based on the performance, the dynamic revetment could be extended farther southeast along the highway.

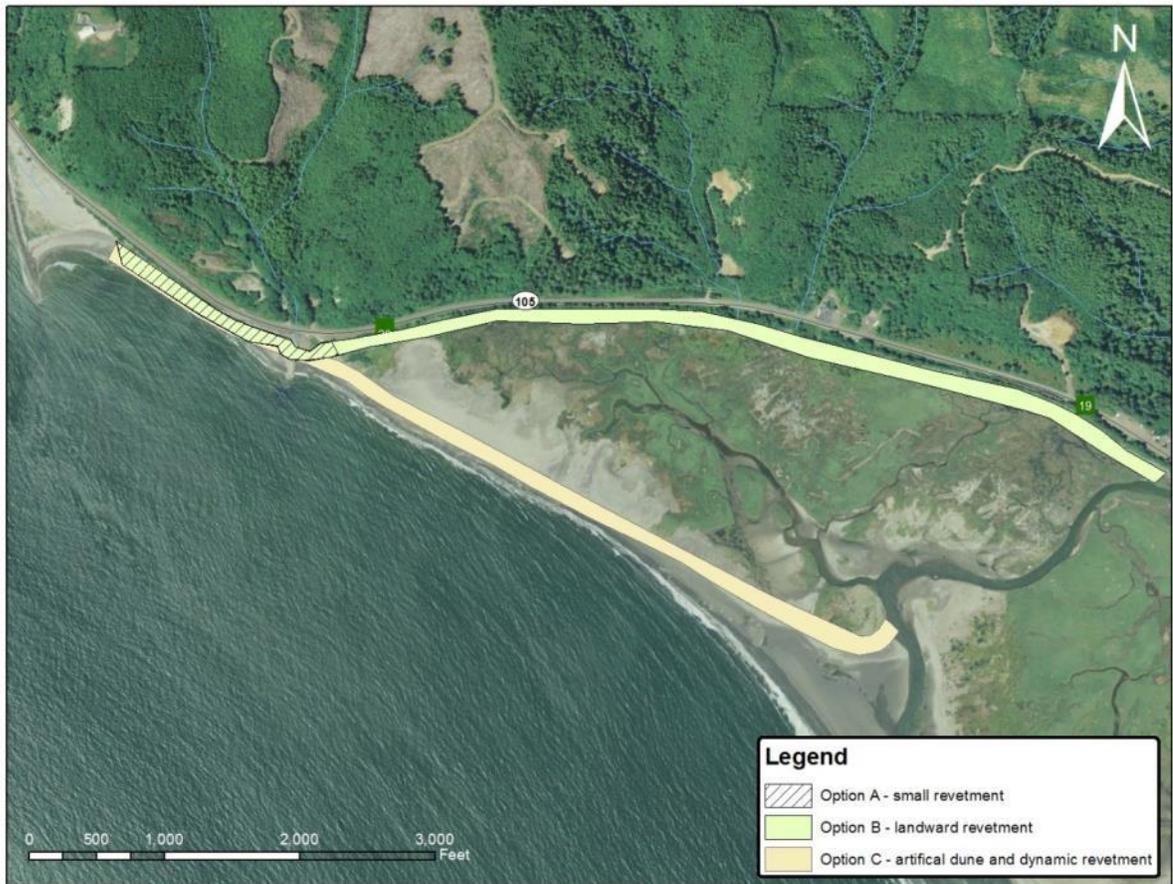
**Figure 47. Options for highway protection incorporating dynamic revetments.**
