Willapa North Shoreline Protection Demonstration Project

Design Report March 31, 2020

Design Report

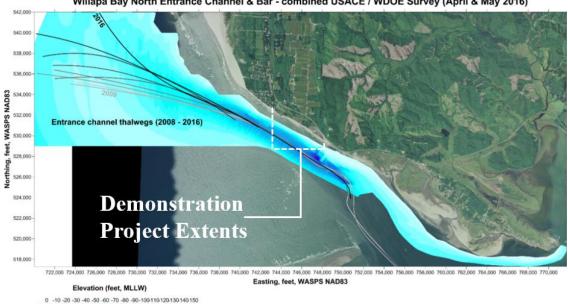
6

Willapa Bay North Entrance Channel & Bar - combined USACE / WDOE Survey (April & May 2016)

Discharge through this channel during peak flood and ebb flows may reach 25,000 - 50,000 cubic yards per second, which is comparable to the discharge of the largest rivers in the world (e.g. the Mississippi River). The North Tidal Channel has migrated constantly during extreme tidal and ocean wave storm events, with a trend of migration (for the last century or longer) towards the North. While migrating to the north, the North Tidal Channel undermines the bottom slope, allows ocean waves to propagate closer to the shoreline, and causes large parts of shoreline to slide into the deep channel. The SR105 project, constructed in 1998, was originally designed to prevent northward migration of the North Tidal Channel along a limited length (approximately 2,500 ft) of shoreline in the vicinity of the most exposed and eroding segment of Highway 105. The analysis of recent data demonstrated the positive effect of the 1998 SR105 project in preventing northward migration of the North Channel and that this effect has extended beyond the expected 2,500 ft. Figure 3 compares the bathymetric surveys in the vicinity of the SR105 project for a period of 21 years, from 1997 (just prior to construction) to 2018 (most recent US Army Corps of Engineers survey).

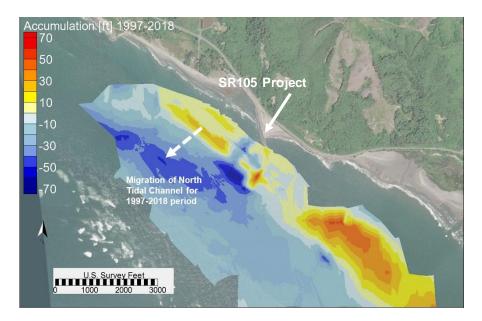
Figure 3 - Bottom depth differences for a recent period of 21 years, between 1997 and 2018. Blue areas in the channel indicated the channel migration to the Southwest.

The figure shows accumulation of sediment in the old thalweg of the North Tidal Channel (in some locations the thickness of accumulation exceeds 50ft) and erosion of the bottom slope seawards of the old thalweg (in some areas the depth of scour exceeds 50 ft). The pattern of bottom depth changes, with accumulation of sediment in the nearshore and deepening (scour) of the bottom slope further offshore, is an indication of North Tidal Channel migration away from the shoreline. The length of the tidal channel affected by this offshore migration is approximately 6,000 ft, which is significantly larger than the 2,500 ft of shoreline expected to be impacted by the SR105 Project. The shoreline within this reach has been protected from northward migration of the channel. Therefore, ongoing erosion of this part of shoreline apparently is driven by a different mechanism: wave erosion combined with a deficit of sediment in the local littoral system (Cause 2). However, for other parts of the North Willapa Bay shoreline (specifically toward the northwest), shoreline erosion may result from a combination of the two major factors: tidal channel migration (Cause 1) and wave-induced erosion (Cause 2). The majority of the Demonstration Project is proposed for the areas where tidal channel migration has been protected (Region 1), and as requested by the Technical Committee was extended into a portion of Region 2 where the tidal channel is migrating.

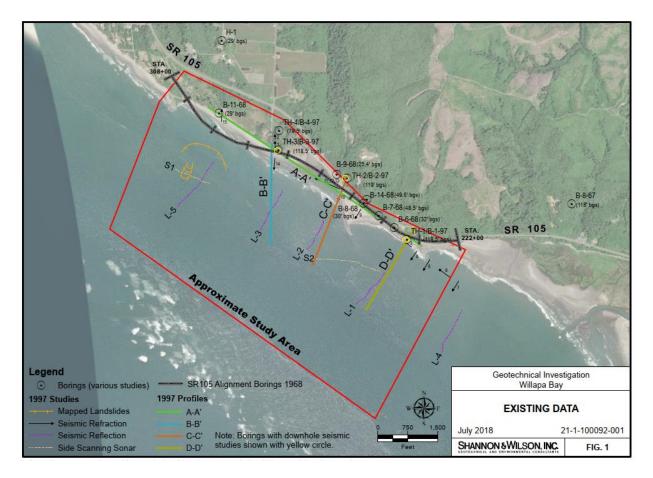
Geologic units mapped in the area and encountered in explorations consist of Holocene beach deposits overlying Pleistocene terrace deposits. Based on the studies and borings reviewed a variable geologic setting within a highly dynamic landscape is interpreted. It's been observed that the depth and properties of the geologic materials vary significantly over sh ort distances. Therefore, it is difficult to use available data to inform site specific conditions at pr posed mitigation sites. To perform geotechnical design for future shoreline migration mitigation measures (e.g. stability, hardening, etc.), site specific subsurface data should be collected. The site-specific data should include one or more over-water borings that extend through the beach and terrace deposits into underlaying tertiary rock, which is anticipated to be below about elevation -100ft. Mean Sea Level (MSL)

Figure 4 - Summary of geologic investigation of the North Willapa Bay shoreline.

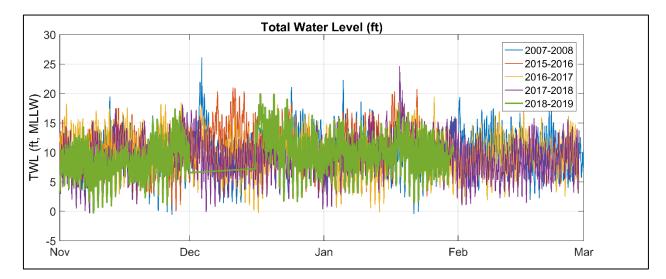
□ Highest observed Hs in winter 2018-2019 corresponds to a 2-year event (~26ft.)

Figure 5 - Concept Level Calculations Total Water Level for key years, 2007-2019. Note that the 2019-2019 season (green line) calculated Total Water Level appears less extreme relative to other key years.

such as those observed in December 2007 or January 2018. The calculated Total Water Level⁷ from the 2018-2019 season is shown in Figure 5.

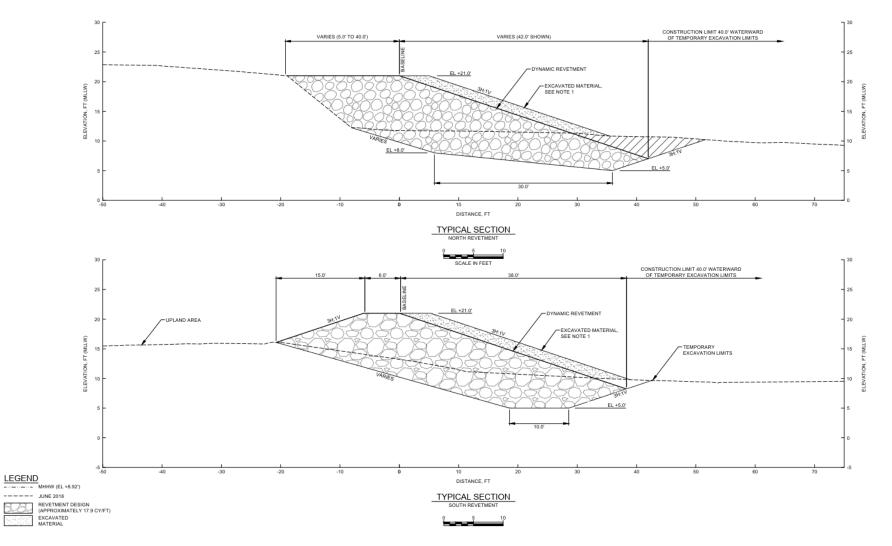
Figure 6 - Representative Cross-Sections of dynamic revetment in the northern (top) and southern (bottom) parts of the project.

- Cross-sectional design volume: 17.5 CY/linear foot (LF); volume may vary slightly along sections, depending on specific existing conditions.
- Crest Height: 21 ft. MLLW
 - □ Note that select sections are higher to tie into existing contours.
- Crest Width
 - Southern: 6 ft.
 - □ Northern: Varies depending on location.
- Front Slope: 3H:1V

- Rock Size:
 - □ 12" minus (no stones larger than 12-inch diameter)
 - □ Selected to give an allowance for fracturing of the larger rocks and to reduce the maintenance requirements, while allowing for a mobile, dynamic profile.

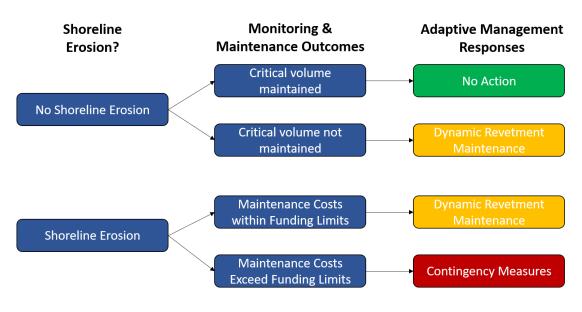
Figure 8 - Conceptual Adaptive Management Scheme

Maintenance may be triggered when the volume of dynamic revetment material remaining at specific cross-sections falls below critical levels (e.g., less than 25-50% of original installation volume) or if shoreline erosion is observed (see Figure 8). The critical volume of dynamic revetment may be represented by a volume per linear foot, a critical cross-shore profile, or a combination of both. It has been estimated that on an annual basis, the average maintenance requirements volume is estimated to be approximately 6,500 CY per year over the next ten years¹³. The post-project monitoring will track the performance of the dynamic revetment and better calibrate the long-term maintenance requirement estimates. The need for contingency measures will be measured against the estimated maintenance levels and maintenance funding availability.

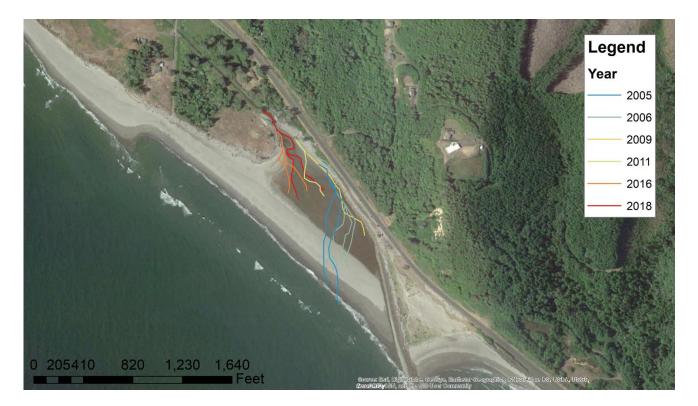
Figure 2 - Historical Drainage Ditch Thalweg Location

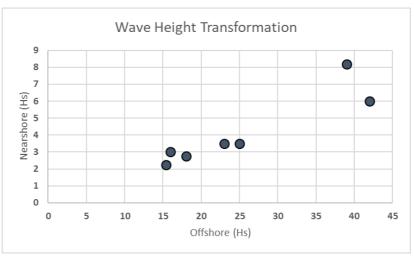
Figure 2. Empirical nearshore wave transformation

Wave data for design of the demonstration project were obtained from compilation, review, and analysis of available measured wave data and information on wave data from previous studies (COE 2009, Delft 2009). Various assumptions and empirical approximation³ to the available data were applied to develop statistical estimates on extreme wave storm events that are applicable for the project site⁴. The results of these estimates are plotted in Figure 2.

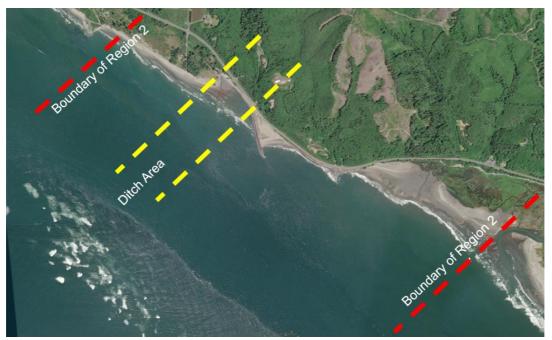
Figure 4. Boundary of Region 2, including Ditch Area

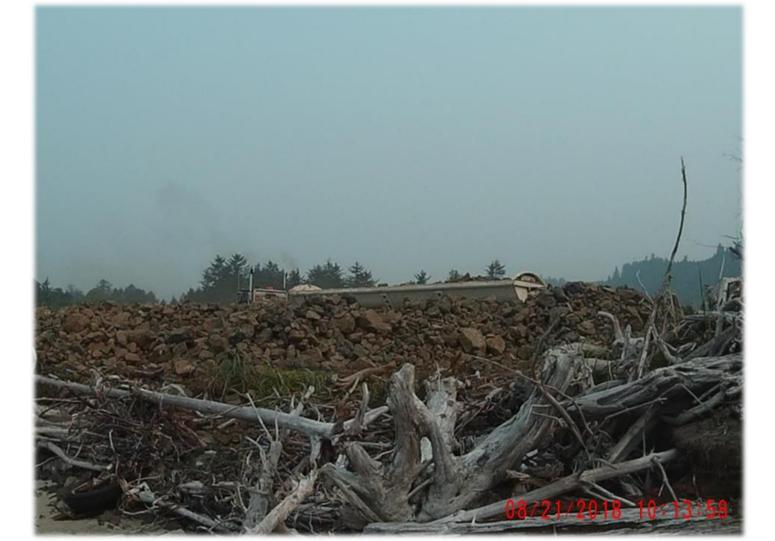
Slide 3: Stone being deposited

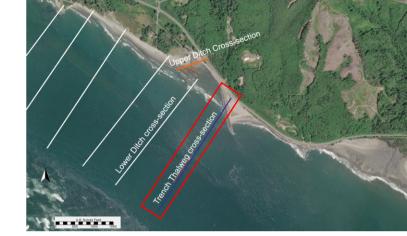
Trench Thalweg cross-section

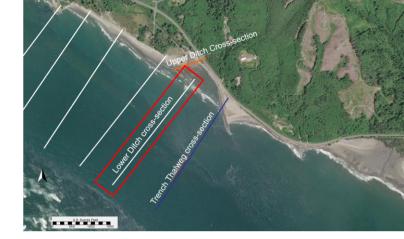
Lower Ditch cross-section

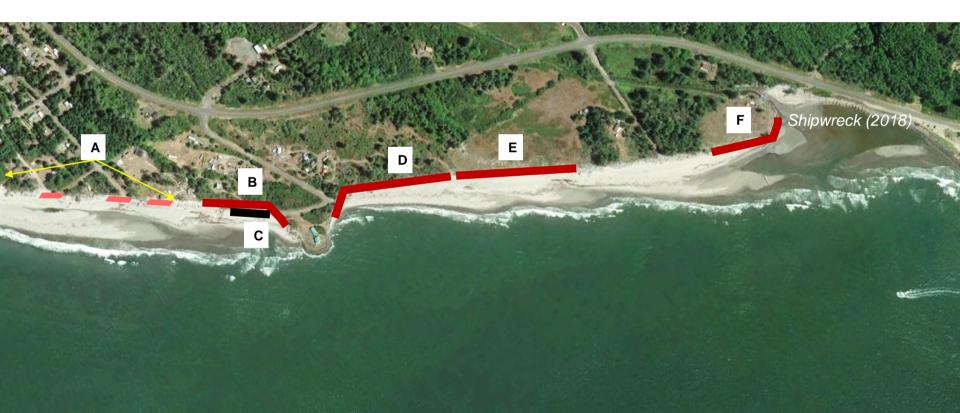
Dynamic Revetment - Rock Placement Areas (2015-2018)

Site	Site Name	Date of Installation	Length	Volume (Estimated)	CY/LF
A	Seamobile	Jan. 2018-Mar. 2018, Dec. 2018	2000 ft.	216 CY	~0.1
В	Ron's	Oct. 2017, Nov. 2017	1000 ft.	408 CY	~0.4
С	Ron's (Buried Rip Rap)	Nov. 2017 – Jan. 2017	400 ft.	2014 CY	~5
D	Brenda's	Dec. 2016, Nov. 2017, Jan. 2018	1000 ft.	400 CY	~1.0-1.5
E	Sandy's	Feb. 2017, Nov. 2017	650 ft.	960 CY	~1.5
F	Lonnie's	Feb. 2017	700 ft.	692 CY	~1.0

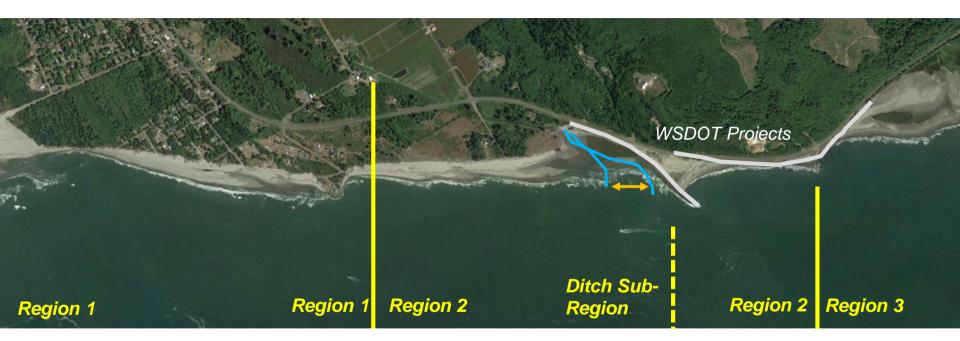
Demonstration Project Extents

- 1. Cover the beach areas most vulnerable to erosion.
- 2. Cover the unprotected critical areas of Region 2.
- 3. Protect highway, drainage district infrastructure, and private properties.
- 4. Information from demonstration project will be applicable to Region 1 and potentially for Region 3.

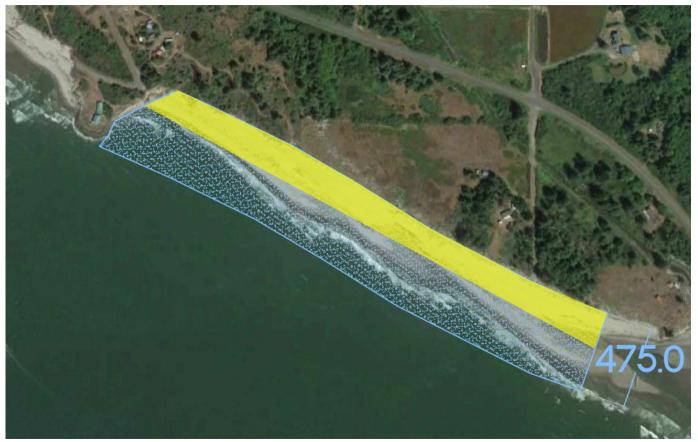
Alternative 5, Beach Nourishment

~400 CY/LF Material

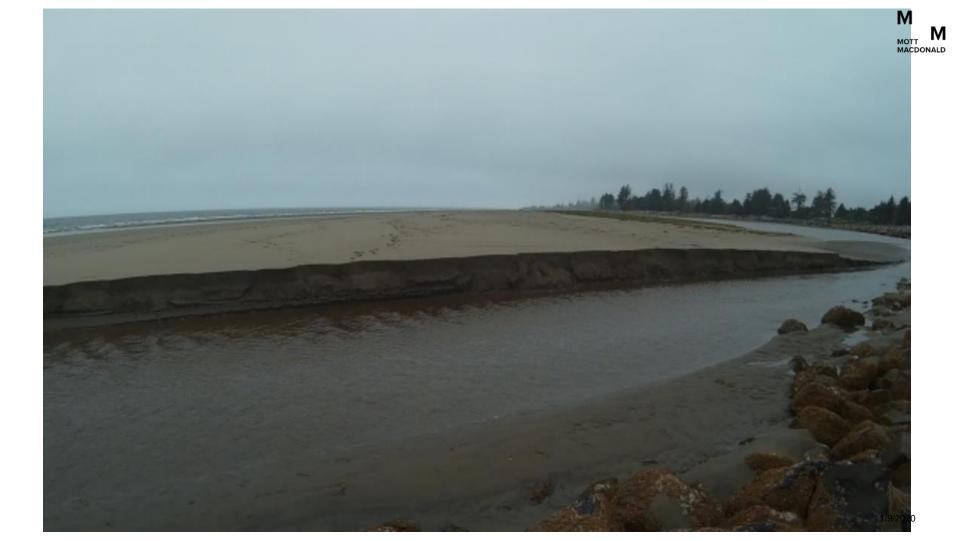
Ditch-Sub Region – Master Plan Update

- Formation of a deep trench has occurred in the area where ditch outflows meets the tidal channel slope. Justifiable explanation to this phenomena has not been developed yet. It may be result of wave or/and flow hydrodynamics, slope instability, avalanching, all of the above, or other.
- Apparently the process of trenching and deepening of the slope and ditch meandering is still going on. It is recommended do not site the demonstration project at the vicinity of this area until clear understanding on this process is achieved.
- Ditch has created significant obstruction to longshore sediment to SE
- Dynamics of ditch results in excessive loss of sand to channel

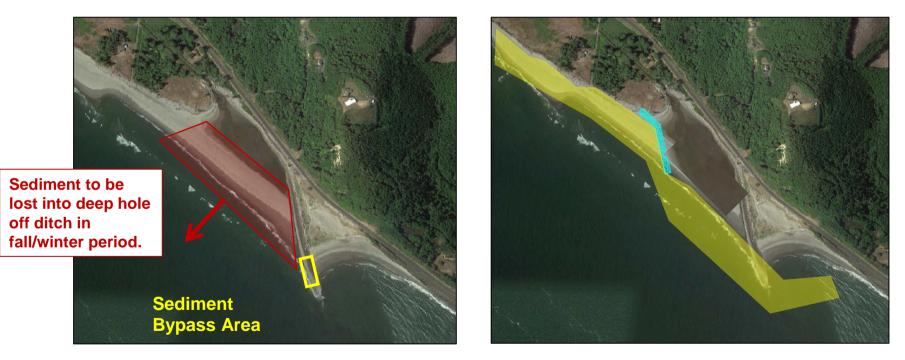
Hypothesis on Groin Benefits

Enhance southeast bypass of sediment to adjacent shoreline Results in formation of the beach in front of significant part of the length of dynamic revetment

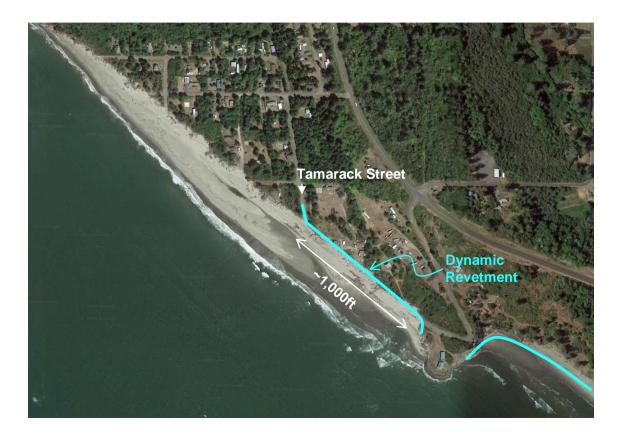
Dynamic Revetment – Northwest extents

- Project extent should be far enough north to demonstrate effect (~900 feet)
- Dynamic revetment should have return to shoreline to reduce risk of undermining and edge effects.
- Permit options tying into Tamarack (~1,000 ft.)

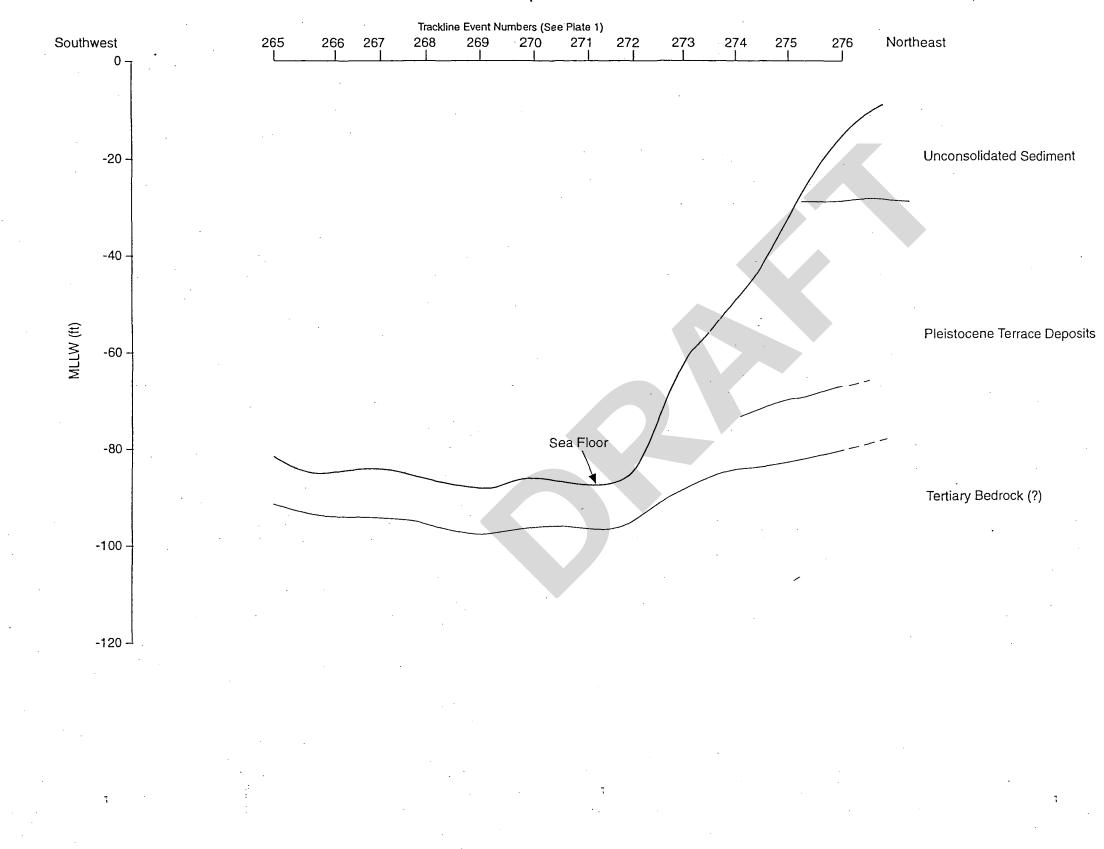
Seismic Reflection L-4 Interpretive Cross Section

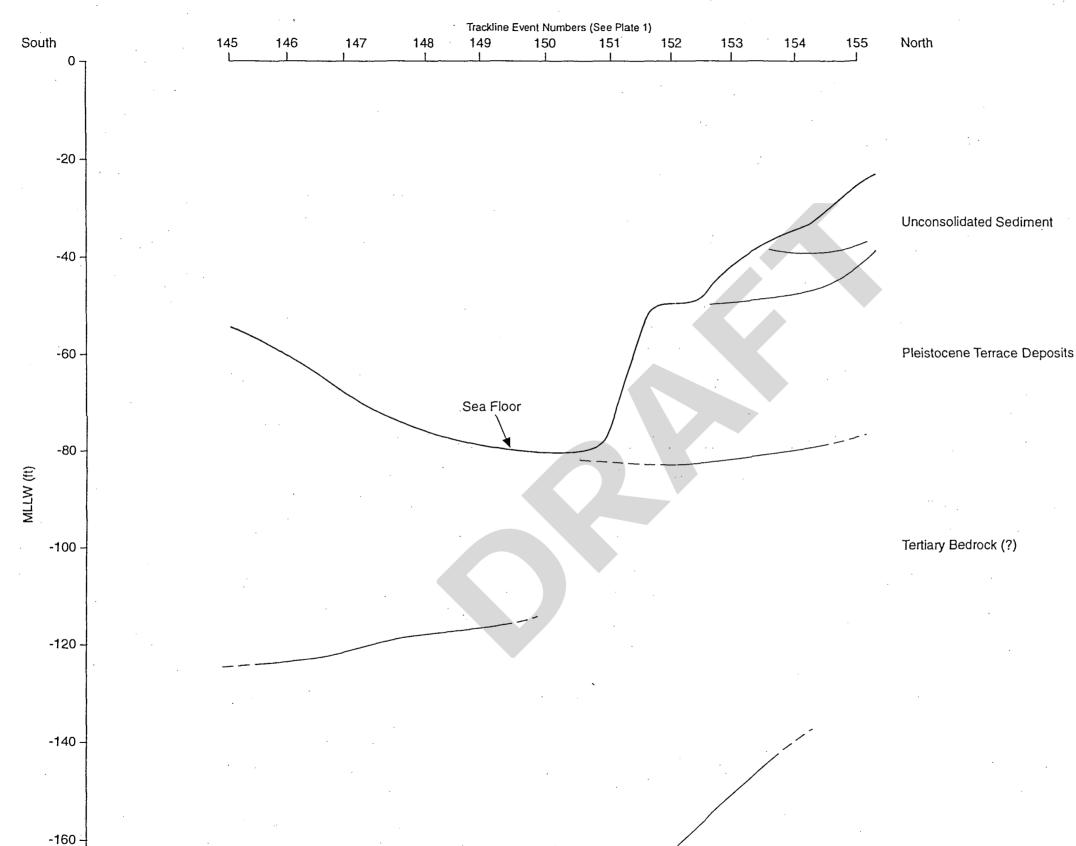
Seismic Reflection L-5 Interpretive Cross Section

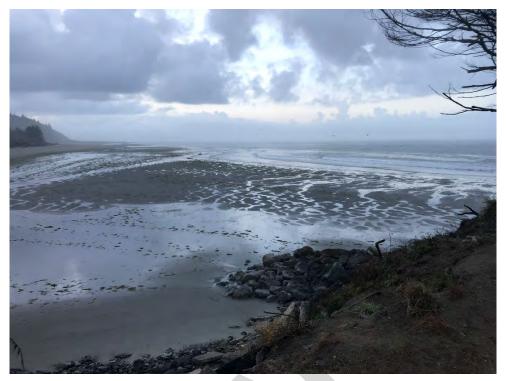
Stop 1: Western end of Region 2 at the old SR 105 eroded bank looking east, September 10, 2018, 7:02 a.m.

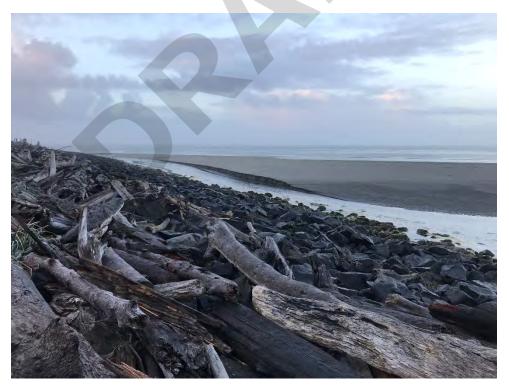
Stop 2: Western flank of the jetty where the drainage ditch meets the jetty and flows out to the Pacific Ocean, September 10, 2018, 7:07 a.m.

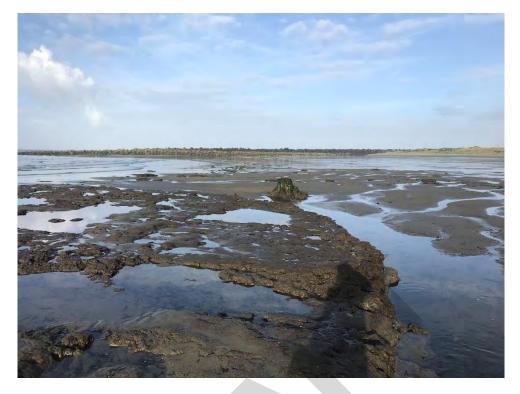
Stop 5: Peat beds with stump, looking west toward jetty, September 10, 2018, 8:19 a.m.

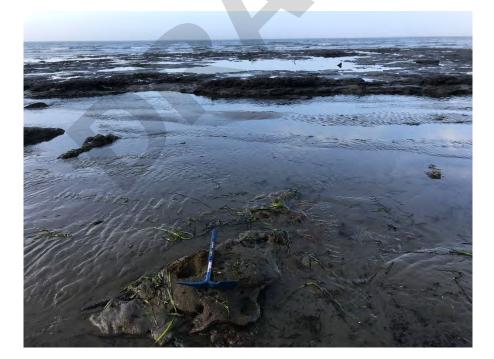
Stop 6: Pleistocene deposits of sandstone with peat bog deposits in background, September 10, 2018, 8:21 a.m.

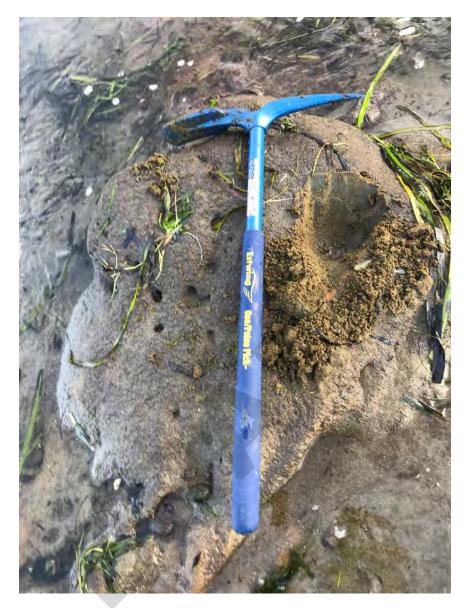
Stop 6: Close up of Pleistocene deposits comprised of iron-stained sandstone, September 10, 2018, 8:21 a.m.

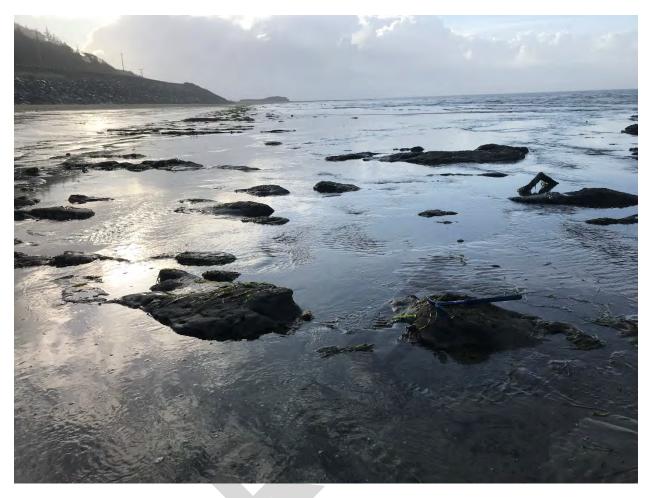
Stop 6: Pleistocene deposit blocks outcropping at beach level, looking east toward prominent Pleistocene deposit outcrop, September 10, 2018, 8:21 a.m.

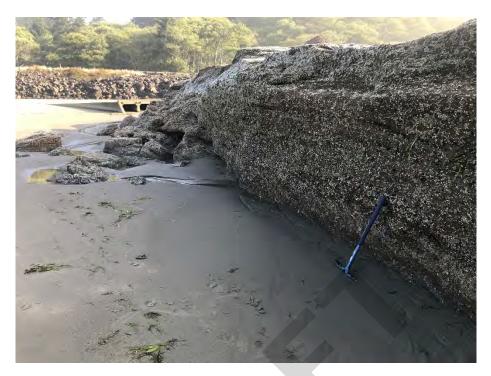
Stop 7: West side of prominent Pleistocene deposit outcrop with cross-bedding at the outlet of Cannery Slough, September 10, 2018, 8:46 a.m.

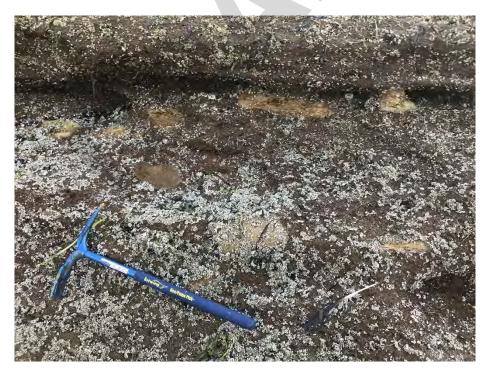
Stop 7: Closeup of Pleistocene deposit outcrop, silt rip-up clasts in a fine silty sandstone matrix. Outcrop comprised mainly of cross-bedded sandstone with gravelly, sandy, and silty sand layers, September 10, 2018, 8:46 a.m.

During our September 10, 2018 site visit we could not see the submarine scarp on the south and west flank of the jetty and groin. We did observe several isolated outcrops of indurated or cemented sand (sandstone) and iron-stained gravel (conglomerate) about 1,000 feet southeast of the jetty and groin and focused around a prominent Pleistocene outcrop near the outlet of Cannery Slough (Figure 3, see also photos in Appendix B). These outcrops represent the hardened or cemented, erosion resistant end-members of the Pleistocene terrace deposits. Outcrops were observed for about 1,500 feet, at Stops 6 through 11. Fine to medium-grained sandstone was observed more often than any other type of material. The proximity of the sandstone (Stop 7) and iron-stained conglomerate (Stop 8), shown in Figure 3, demonstrates the spatial variability in density and grain size in these materials. This variability will likely continue into the subsurface, as well. Holocene deposits appear to be actively eroding, including the peat bog deposits at Stops 5, 12 and 13 and Estuarine deposits at Stop 14 are being actively eroded. These deposits likely remain because of the clay and silt content, whereas sandy beach deposits more easily wash away.

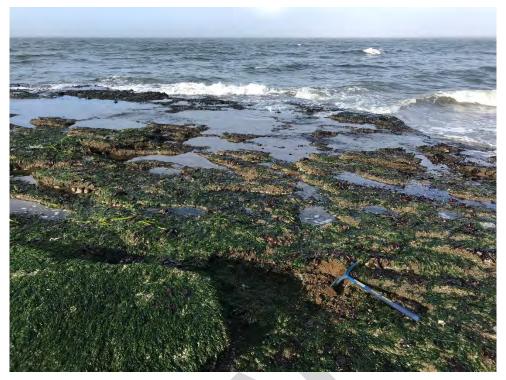
Stop 8: Pleistocene deposits (sandy gravel conglomerate) at beach level south of prominent Pleistocene outcrop, September 10, 2018, 8:52 a.m.

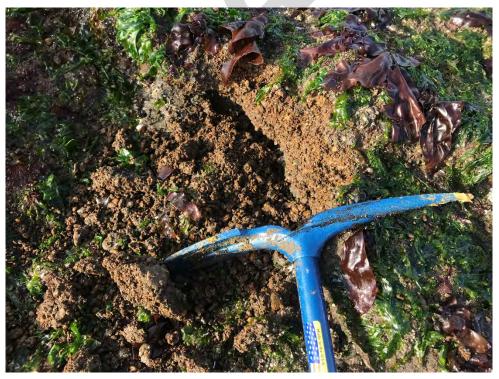
Stop 8: Iron-stained, sandy gravel conglomerate, Pleistocene deposits Monday, September 10, 2018, 8:52 a.m.

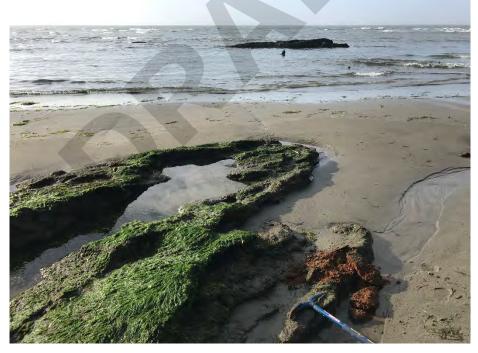
Stop 10: Pleistocene deposit outcrop at beach level comprised of iron-stained, coarse-grained sandstone and gently dipping east beds (looking south), September 10, 2018, 9:02 a.m.

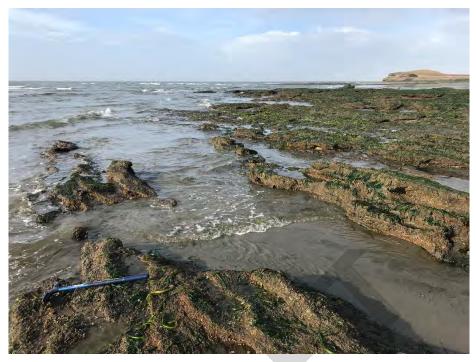
Stop 11: Pleistocene deposit outcrop (sandy gravel conglomerate to sandstone) at beach level looking west with gently dipping west beds, September 10, 2018, 9:10 a.m.

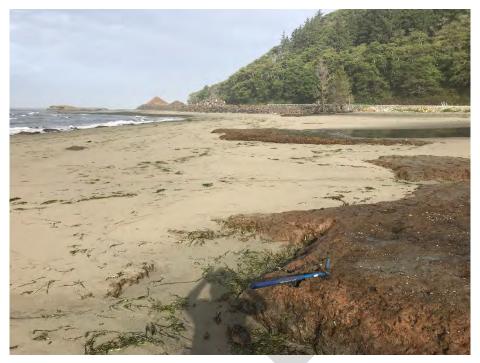
Stop 12: Eroding peat bog deposits at beach level looking north inland, September 10, 2018, 9:10 a.m.
