SR 105 MP 20 Washaway Beach 2019 Dynamic Revetment Monitoring Report

**Rob Schanz PE, LG, Hydrologist
Garrett Jackson LG, Hydrology Program Manager
WSDOT Headquarters Hydraulics Office**

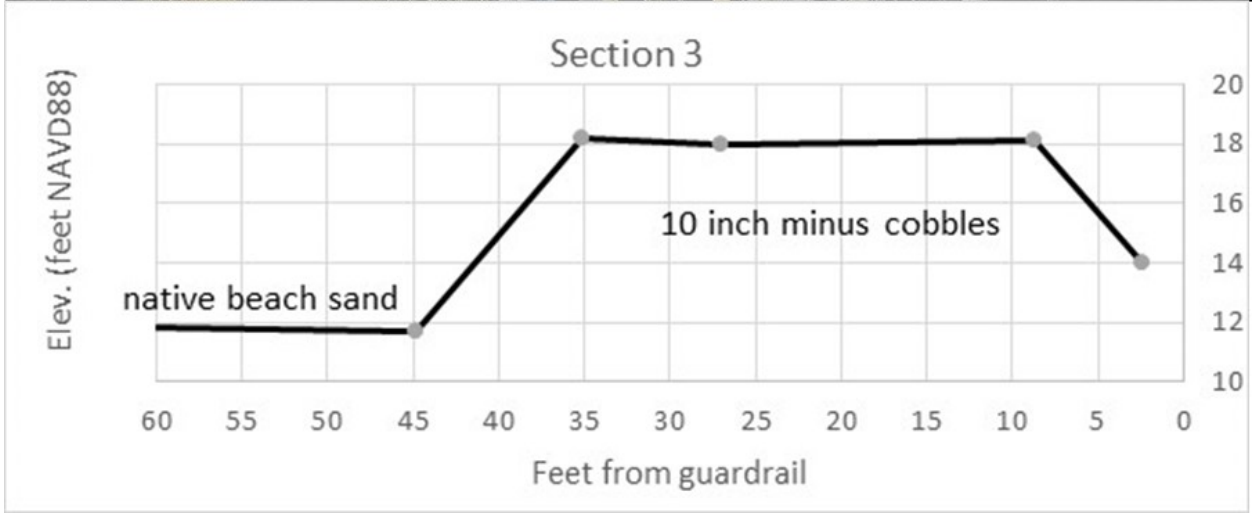
Figure 2. As-built condition of the eastern dynamic revetment (looking west).

The eastern 260 feet of dynamic revetment was constructed with a 26-foot top width (Figure 2). The back side of the berm sloped at about 2:1 to meet the edge of the roadway a few feet behind the guardrail. The berm was constructed of 10-inch minus streambed cobbles.
