Case Study: Shoreline Stabilization

Chinook, Washington

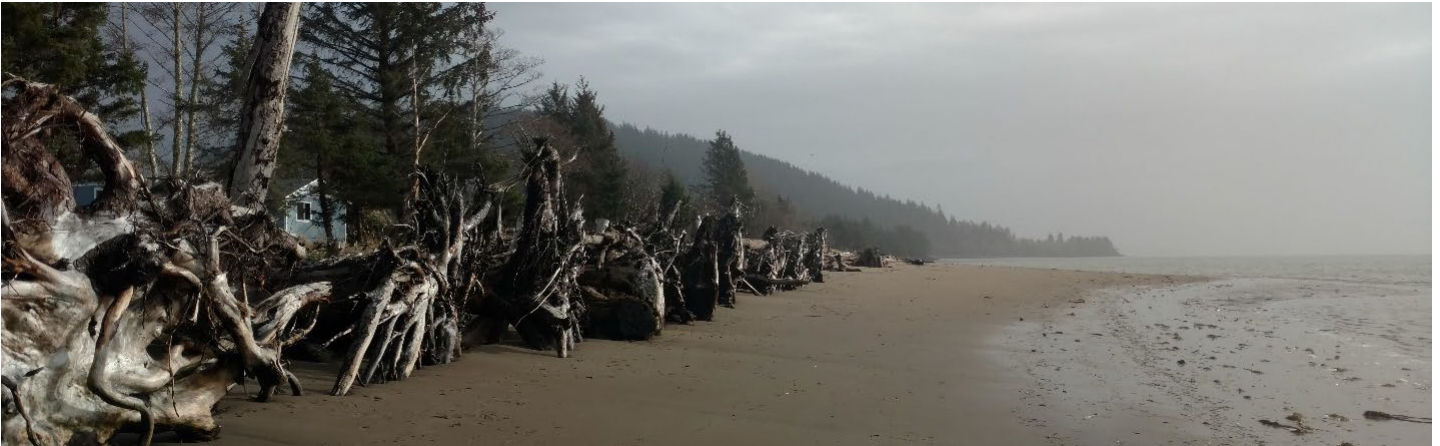
*A line of root wads defends against erosion and collects sediment. Pictured at low tide.
(Photo credit: Jackson Blalock, The Nature Conservancy)*

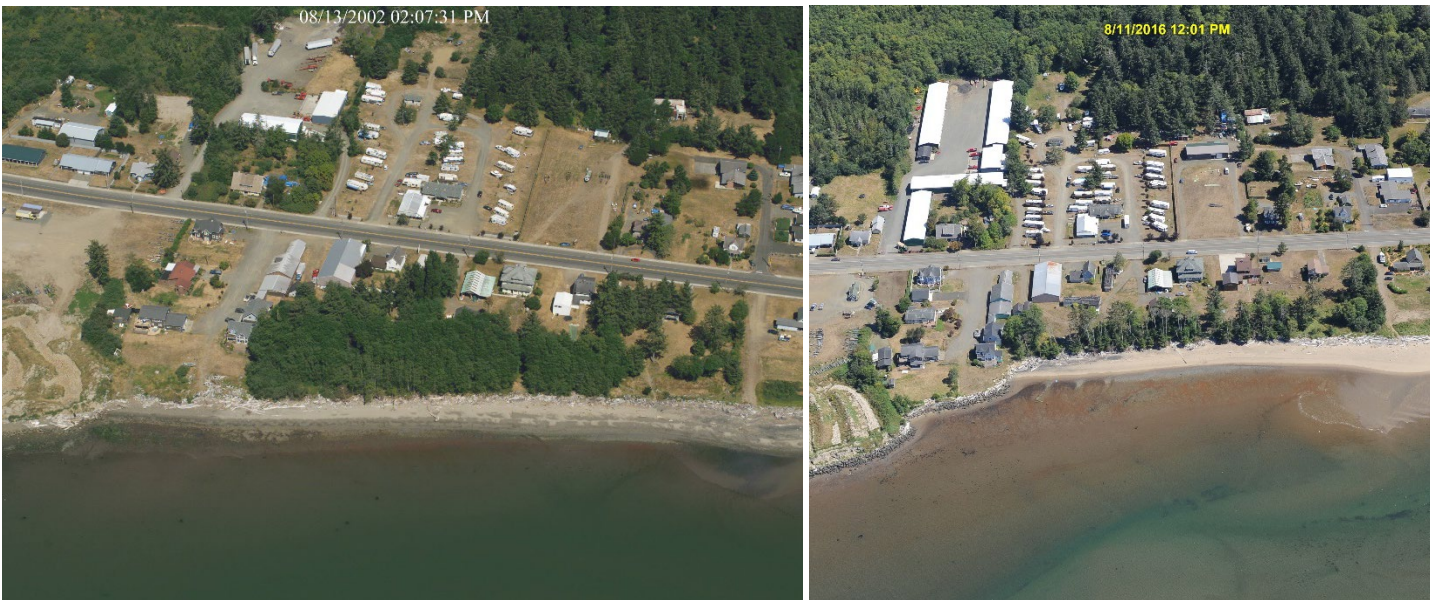
*Aerial photographs of the site from 2002 (left) and 2016 (right) show shoreline trees lost to erosion.
Note presence of shoreline armoring in 2016 photograph—shoreline stabilization structure was later installed on the beach to the right of this armoring. (Image credit: Washington State Department of Ecology's Coastal Atlas)*

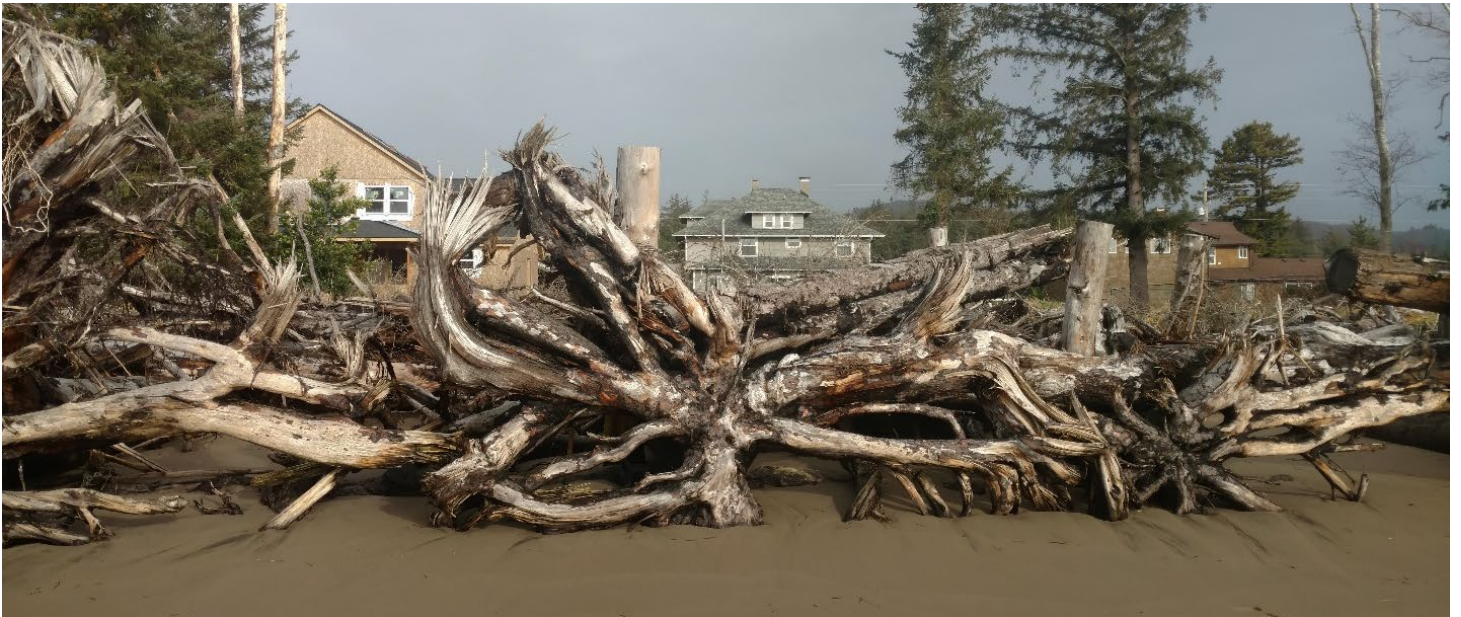
*Root wads with intact trunks face the water, helping dissipate wave energy.
(Photo credit: Jackson Blalock, The Nature Conservancy)*

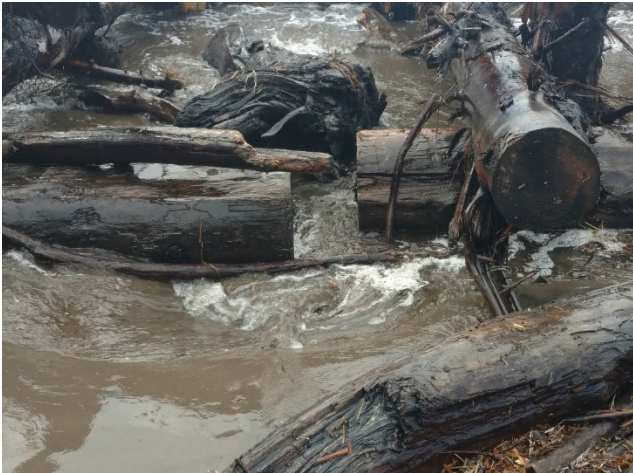
Top left: Scour is evident where water passes through gaps in the structure, making the structure less stable.

- Ensure root wads do not move by anchoring them from multiple angles. In this project, this was accomplished by bolting root wads, log piles, and toe/brow logs together with threaded rods running through both structural elements. As a result, bolted connections sit perpendicular to each other, providing improved stability.
- Toe logs should be sufficiently buried to prevent water from flowing below them and scouring sediment.
- Link or overlap toe logs to prevent scour in gaps or spaces between them due to wave action.

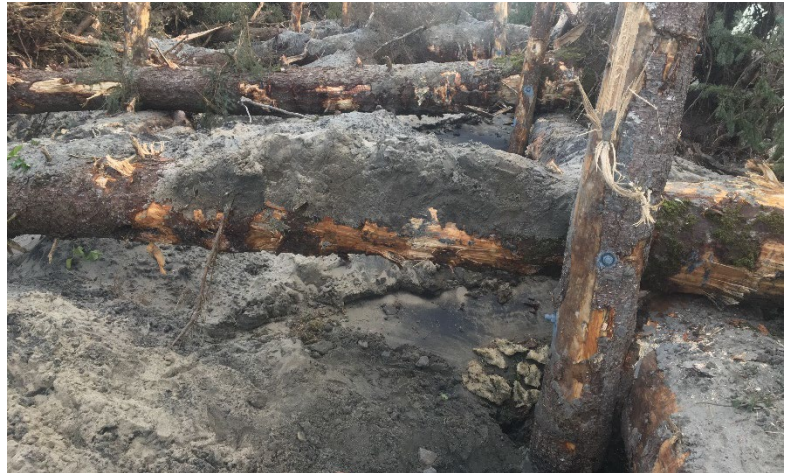
Top right: threaded rods (blue) bolted through structure at perpendicular angles.

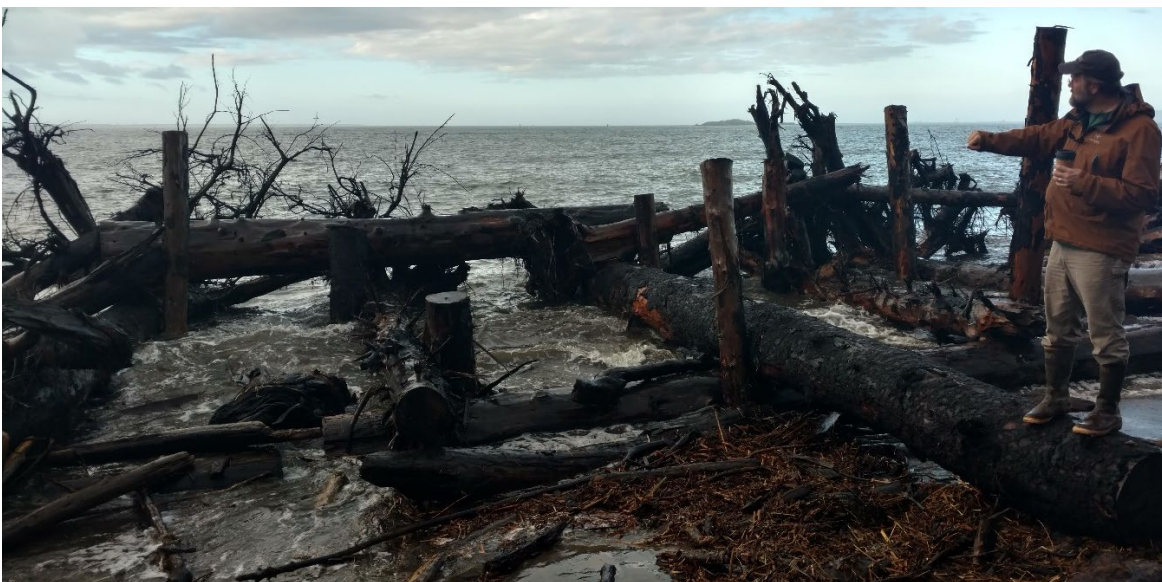
Bottom: Tom Kollasch of Pacific Conservation District shows how the structure dampens waves during a winter high tide.

Note the pile of material that has been deposited landward of the structure.

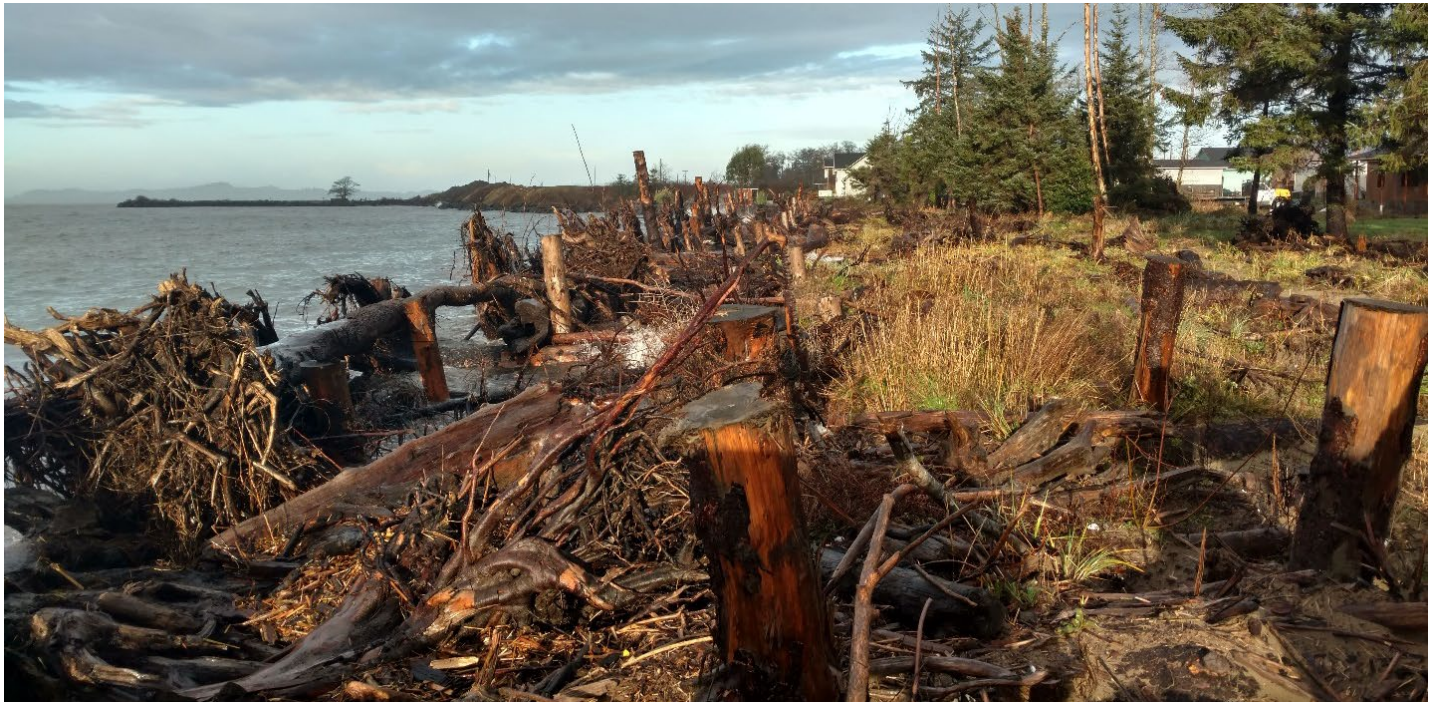
*Erosion control structure at high tide, with eroding shoreline on right half of image. Note homes on right side of image.
(Photo credit: Jackson Blalock, The Nature Conservancy)*
